# TOLLESHUNT D'ARCY PARISH COUNCIL

## AGENDA

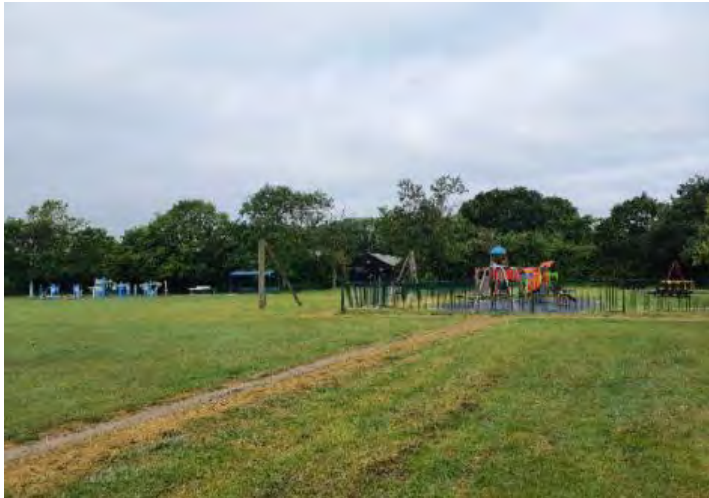
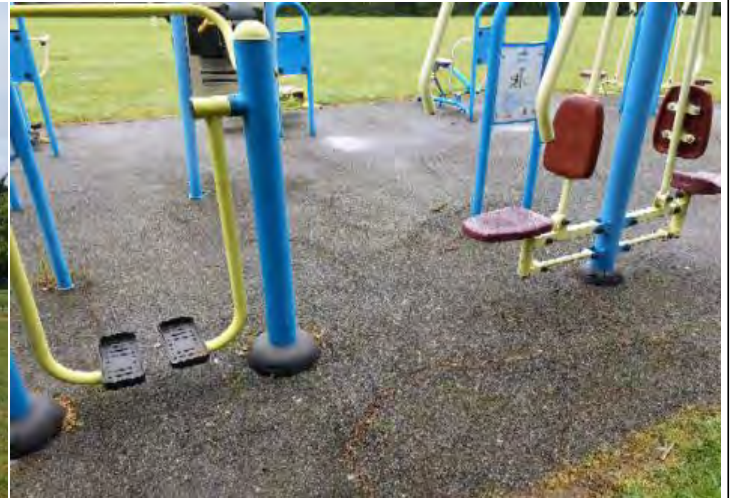
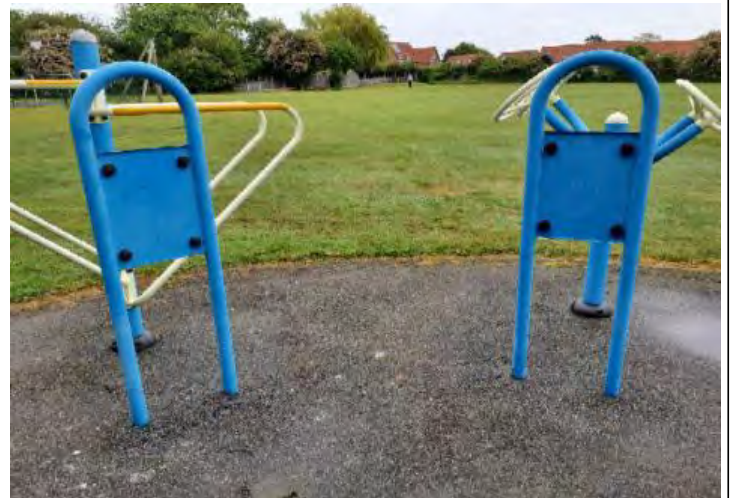
**Finding:** The training space of the fitness items overlap in contravention of the requirements of BS EN 16630

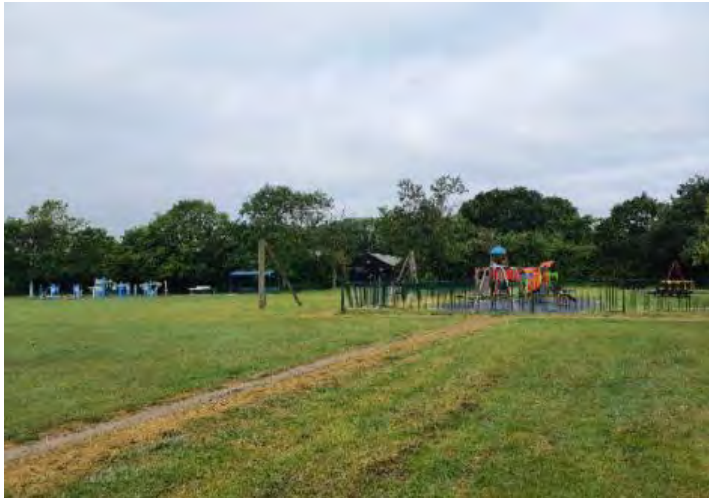
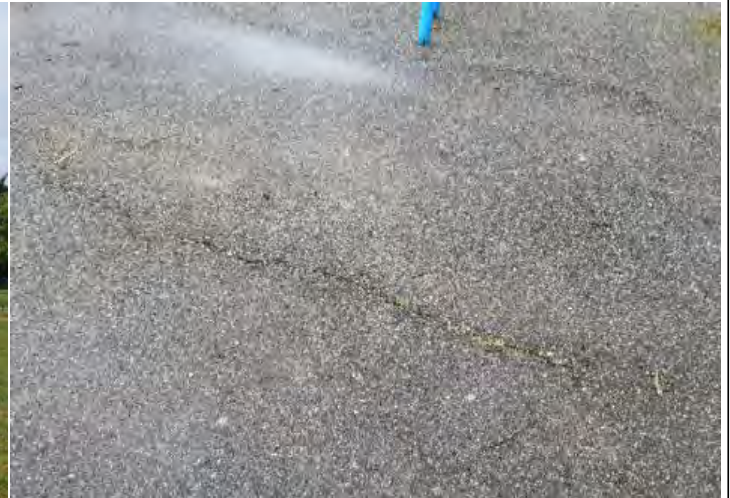
**Finding:** There is some minor damage to the surface  
**Action:** Monitor for any further deterioration and repair as required

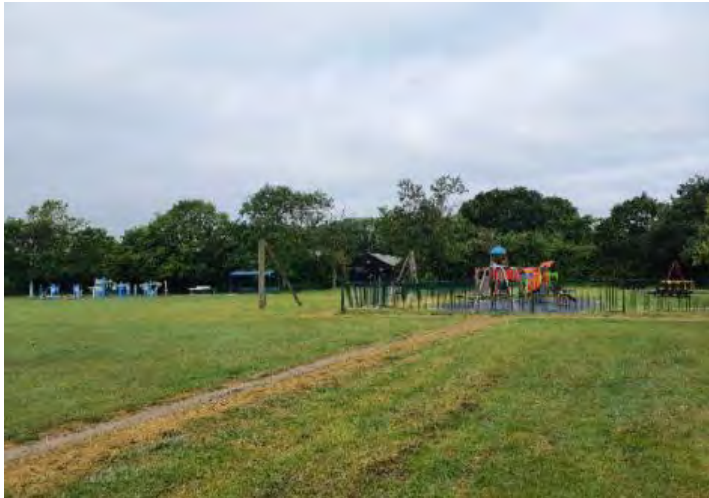
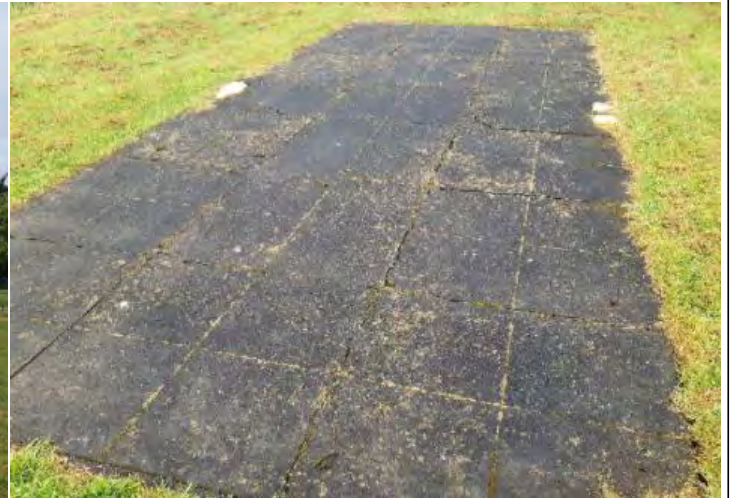
**Finding:** The tiles on the unused base are damaged

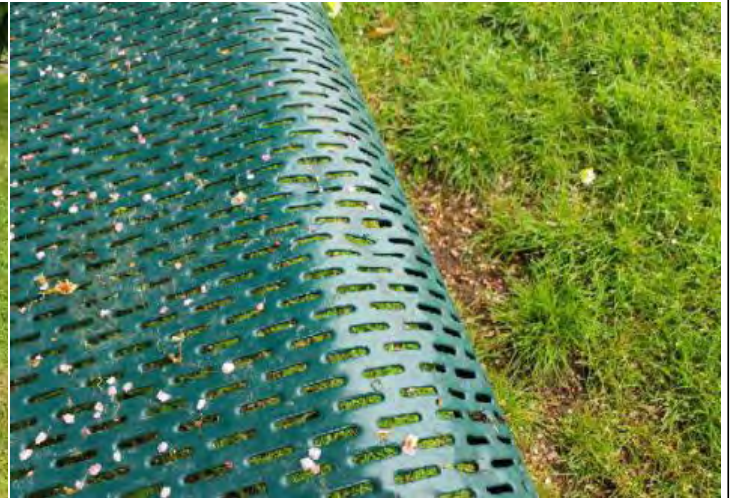
**Finding:** There is some damage to the item

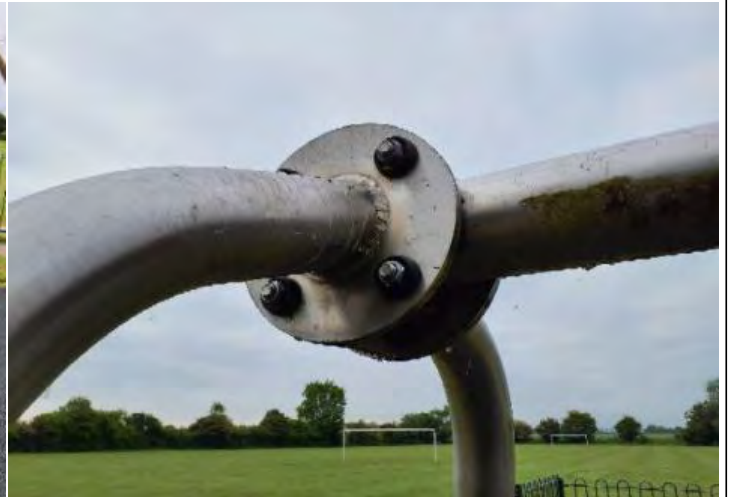
**Finding:** There is/are bolt cap covers missing or damaged on the item

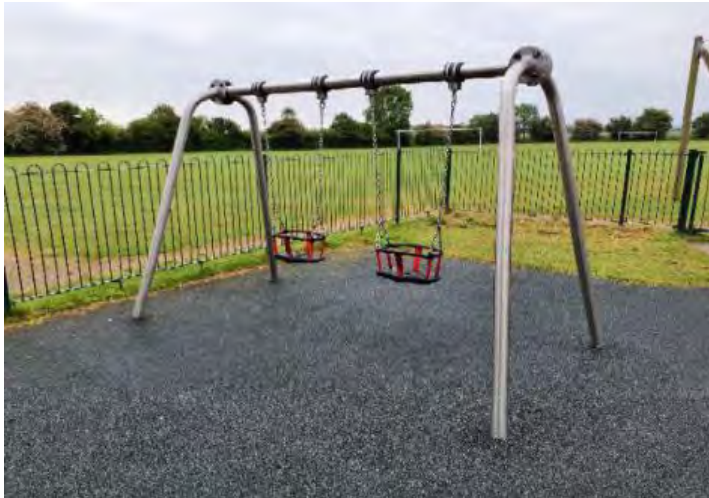
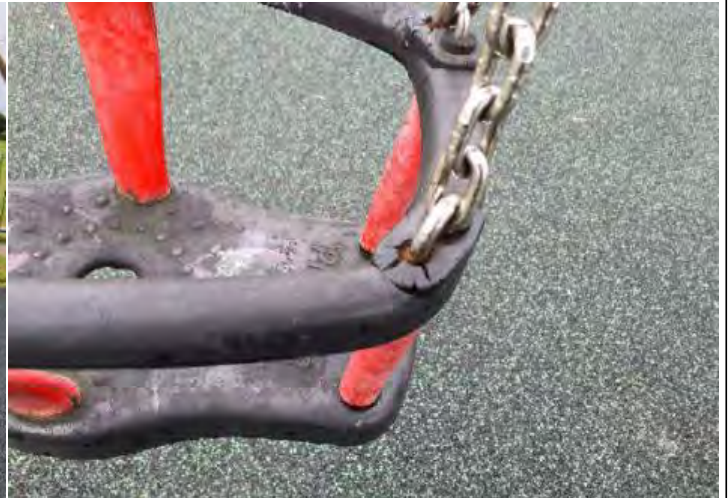
**Finding:** The seat has minor damage or wear

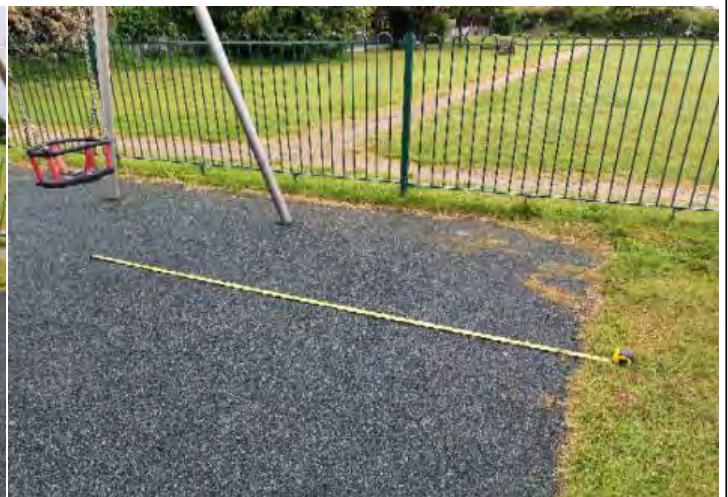
**Finding:** The timber edge forms a hard object within the impact area of the equipment in contravention of the requirements of BS EN 1176 Part 1

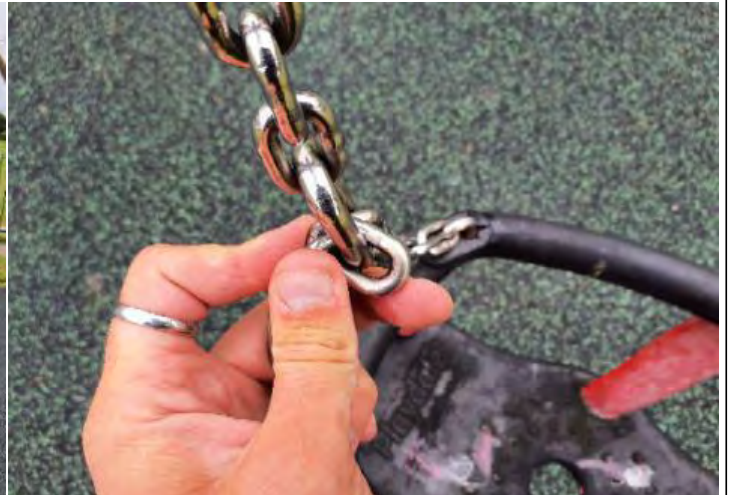
**Finding:** There is some notable evidence of chain wear

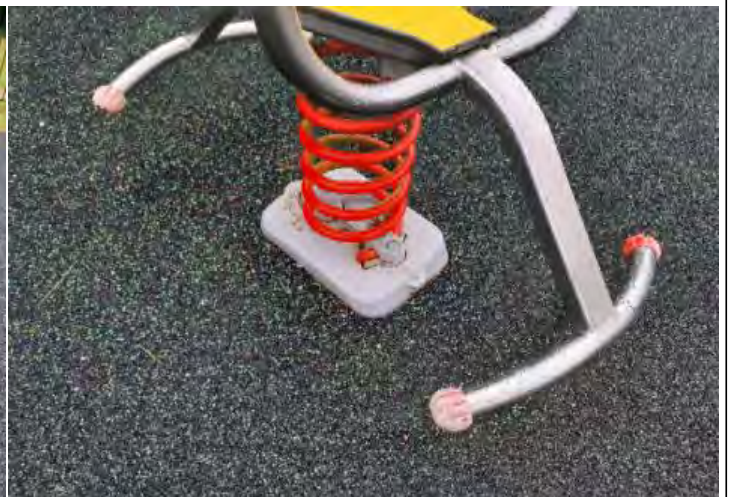
**Finding:** The spring clamps are loose

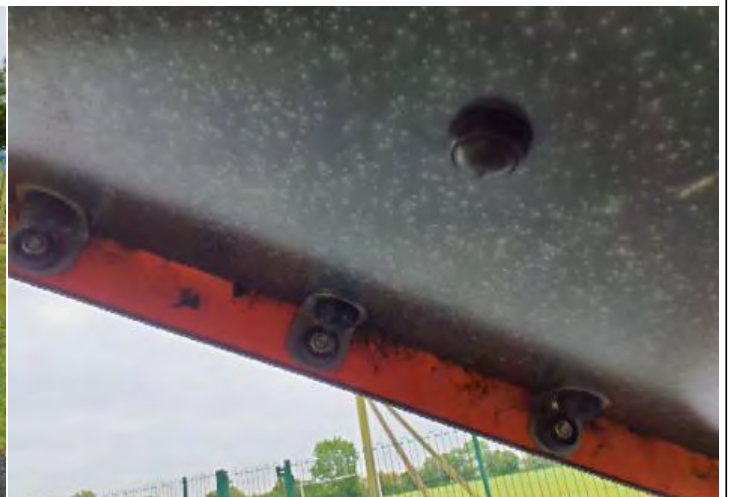
**Finding:** There is/are bolt cap covers missing or damaged on the item

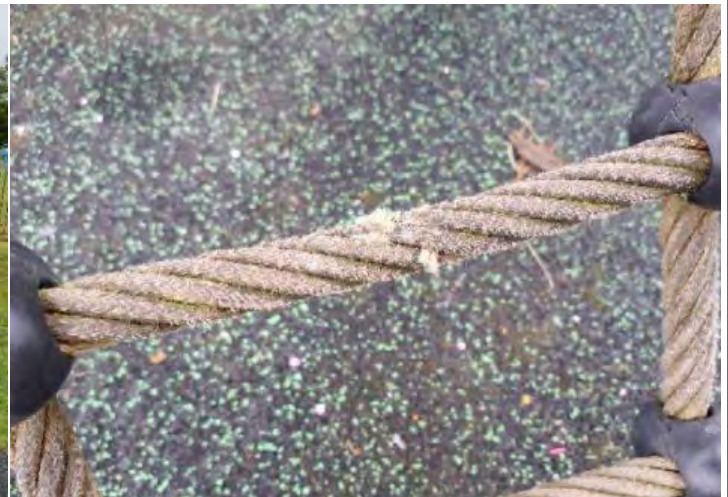
**Finding:** The ropes/nets are worn/damaged in places

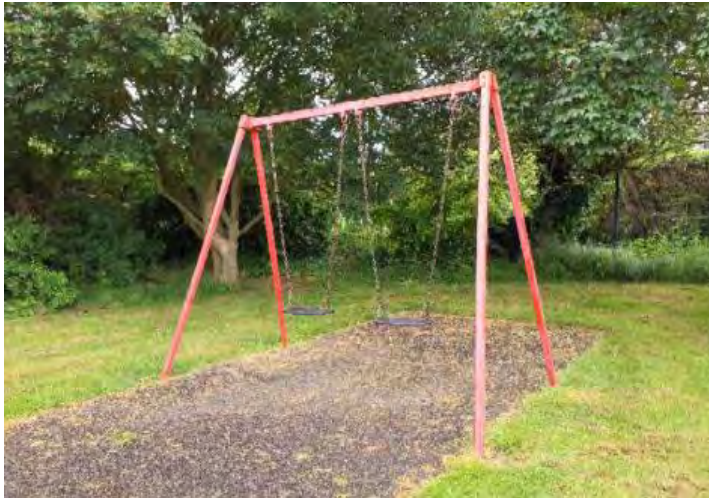
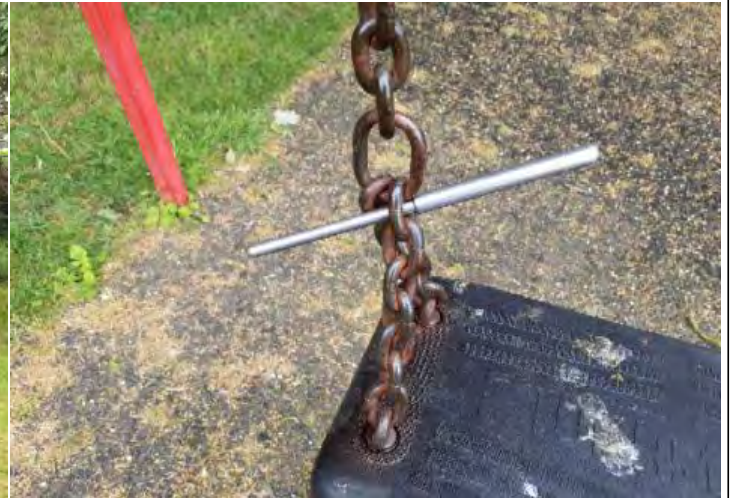
**Finding:** The chain openings are in excess of 8.6mm and do not meet the recommendations of BS EN 1176 Part 1

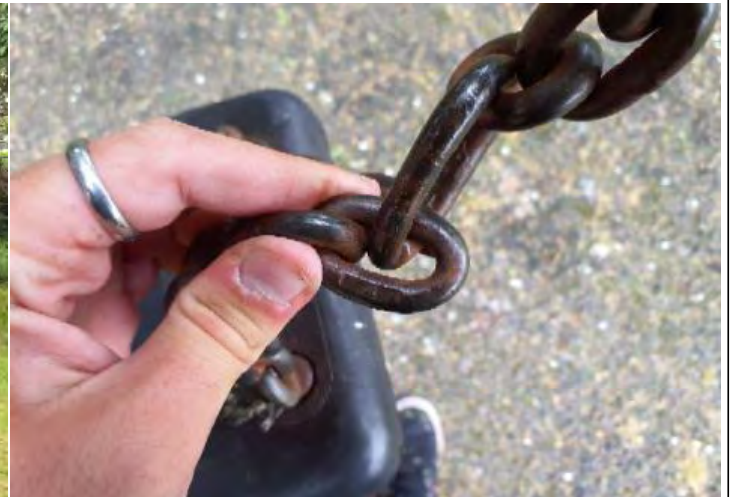
**Finding:** There is some notable evidence of chain wear

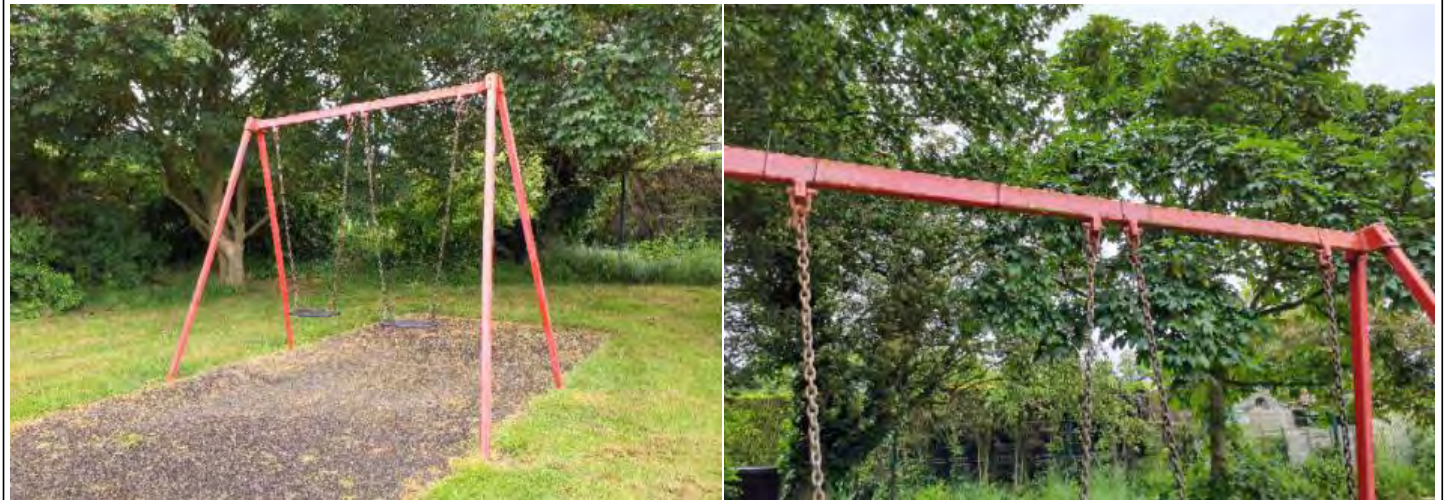
**Finding:** There is some wear to the shackles  
**Action:** Monitor for any further deterioration and replace when 40% worn

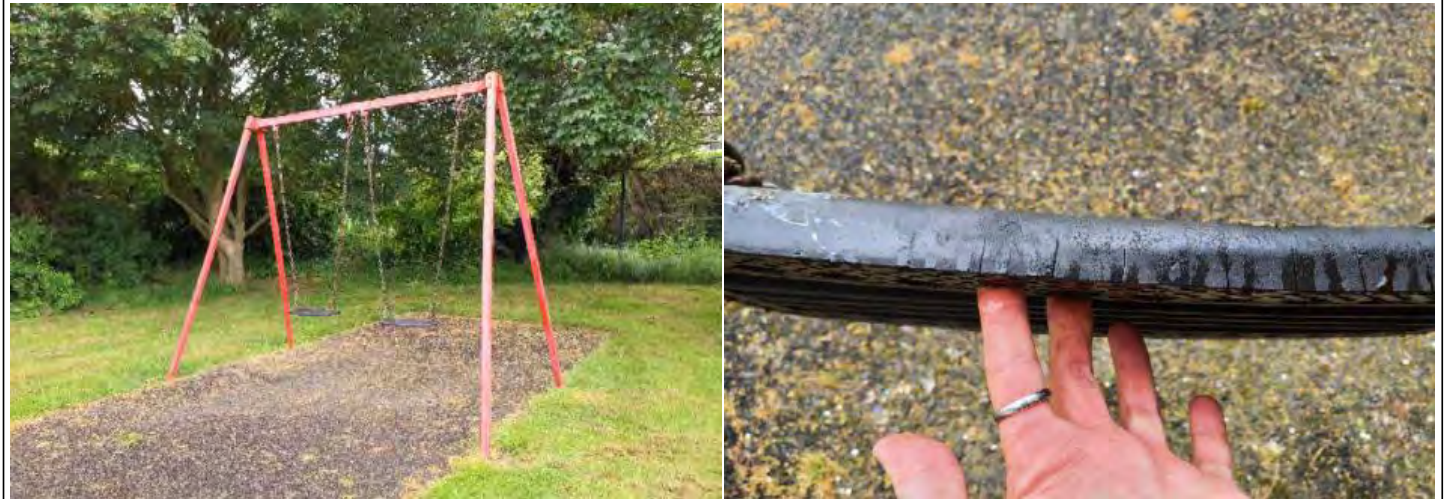
**Finding:** The seat has minor damage or wear  
**Action:** Monitor for any further deterioration and replace as required

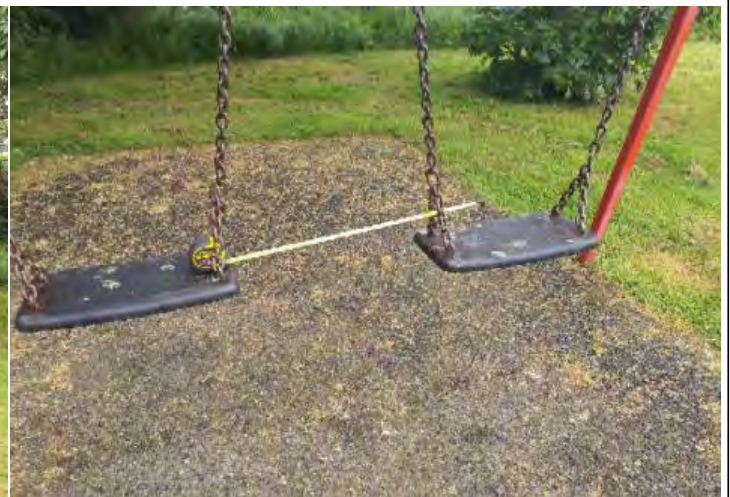
**Finding:** The seats are too close to each other as defined in BS EN 1176 Part 2; this is a low risk failure and no remedial action is required  
**Action:** Monitor - No remedial work recommended

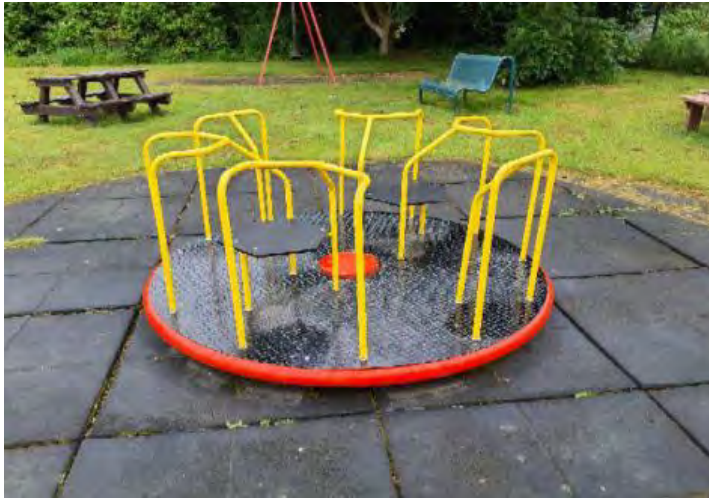
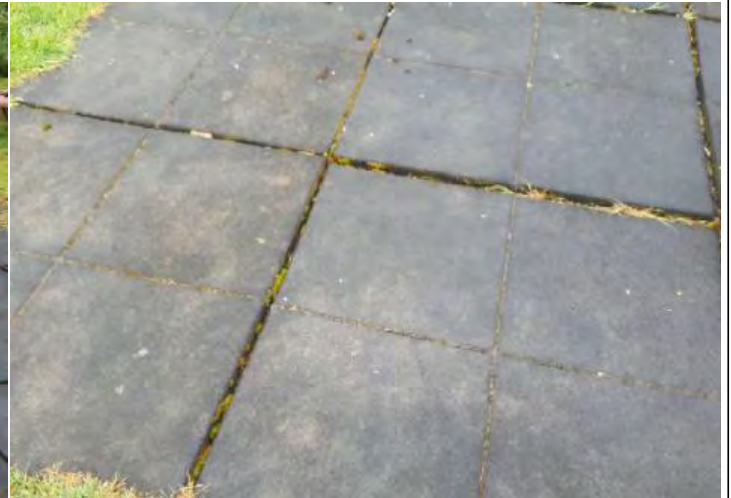
**Finding:** There are gaps opening in between the tiles

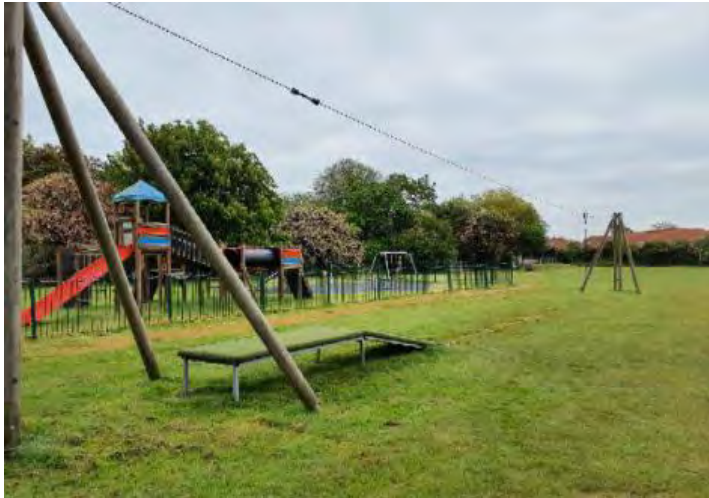
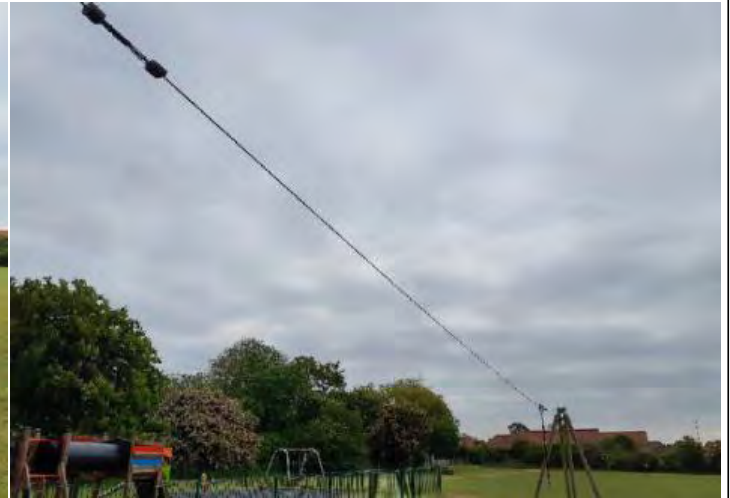
**Finding:** We have completed a visual inspection of the suspension links, cable and fixing points from ground level, however it is not possible to fully inspect these areas without either hiring equipment to gain access or removing the cable and suspension and inspecting at ground level. We recommend that the main cable and fixing security is thoroughly inspected at least in accordance with the manufacturers recommendations to check for wear, damage, security or internal rusting; this will help to ensure the continued safe use of the equipment

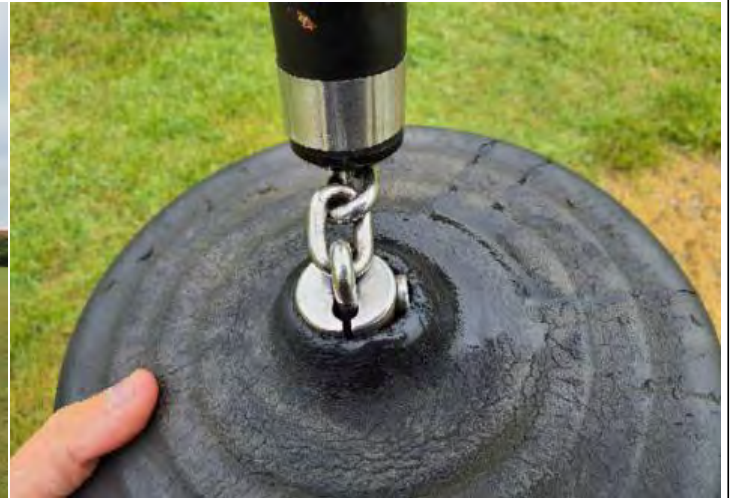
**Finding:** There is some notable evidence of chain wear

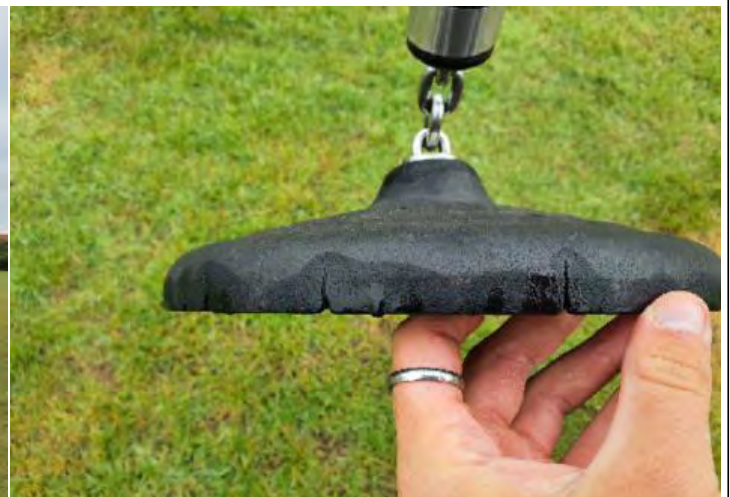
**Finding:** The cableway seat has been damaged

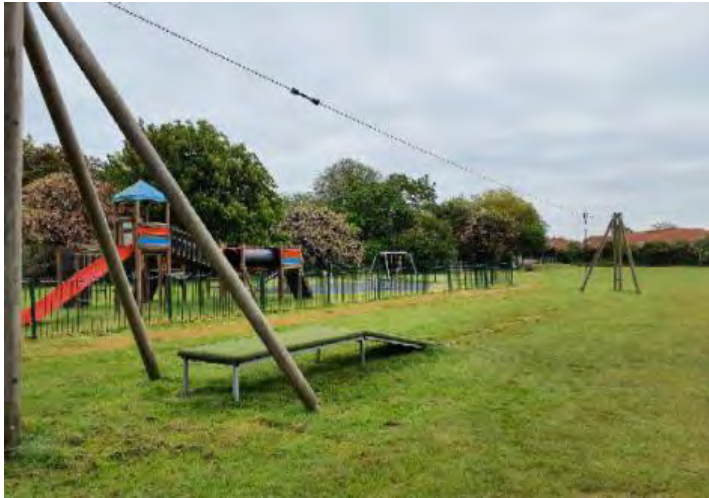
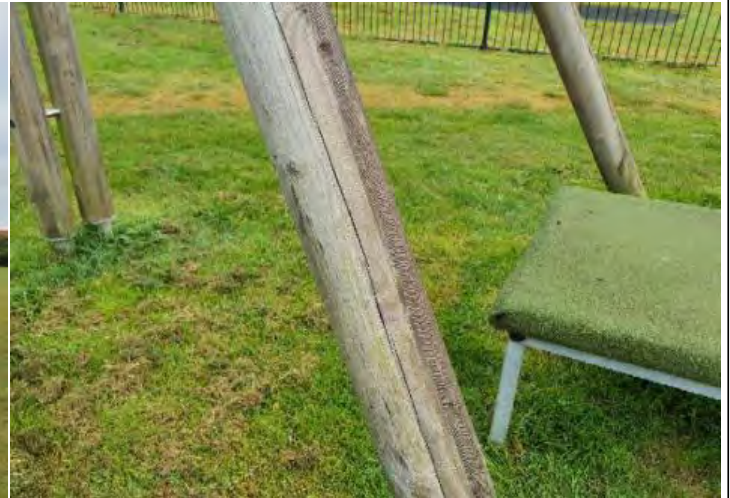
**Finding:** The timber has a number of splits/shakes or air cracks and this may affect the stability or allow water ingress which will accelerate the rotting process  
**Action:** Monitor to ensure the splits do not cross through fixing points of the structure and/or cause any instability

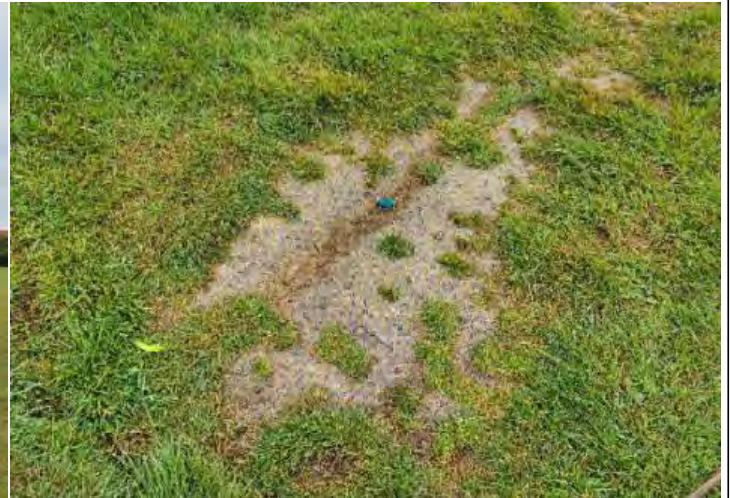
**Finding:** The grass mats are silted up and the soil is compacted; this may have an effect on the impact absorbing properties of the surface

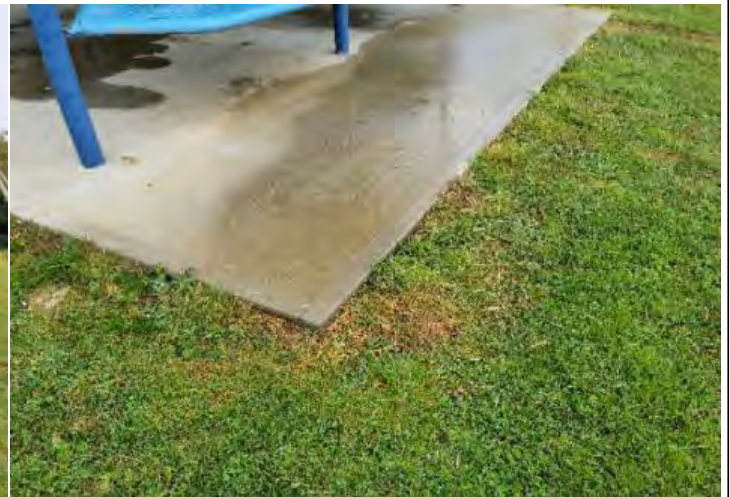
**Finding:** There are trip hazards at the edges of the surface

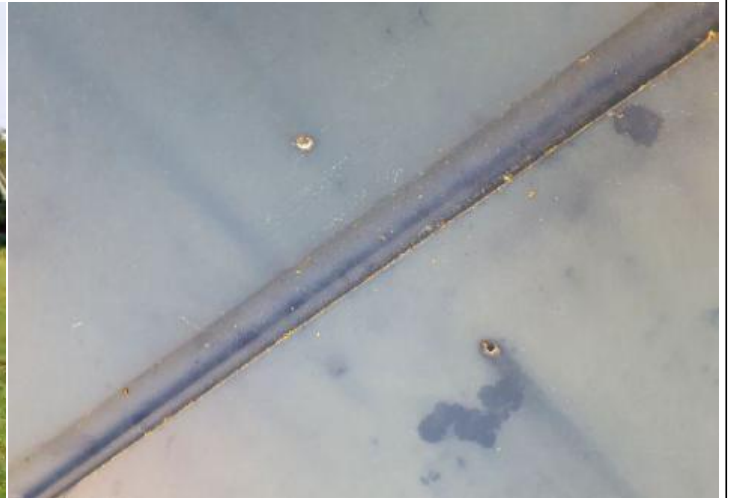
**Finding:** There is or are fixings missing on the item

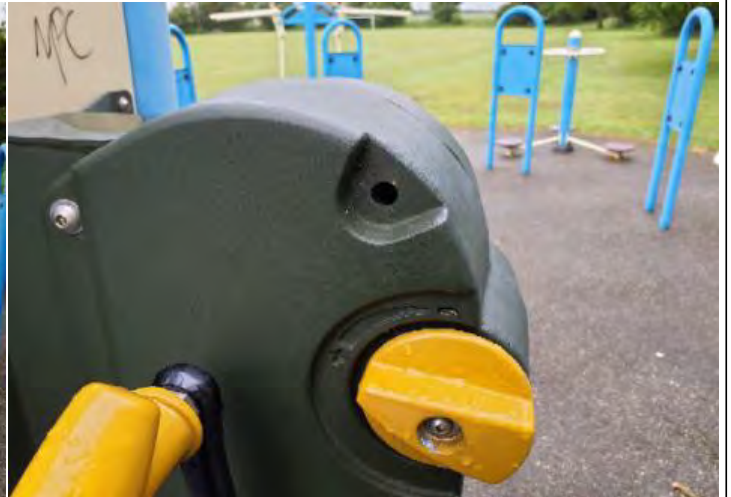
**Finding:** There is or are fixings missing on the item

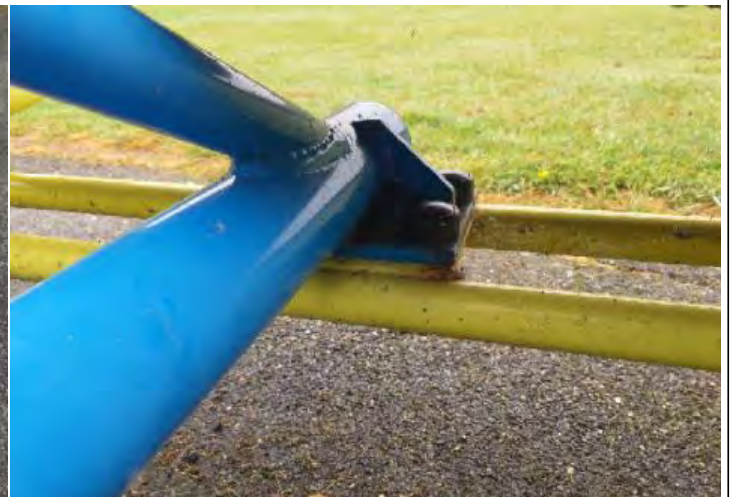
**Finding:** The paintwork on this item has been damaged or worn exposing the metal underneath which is rusting

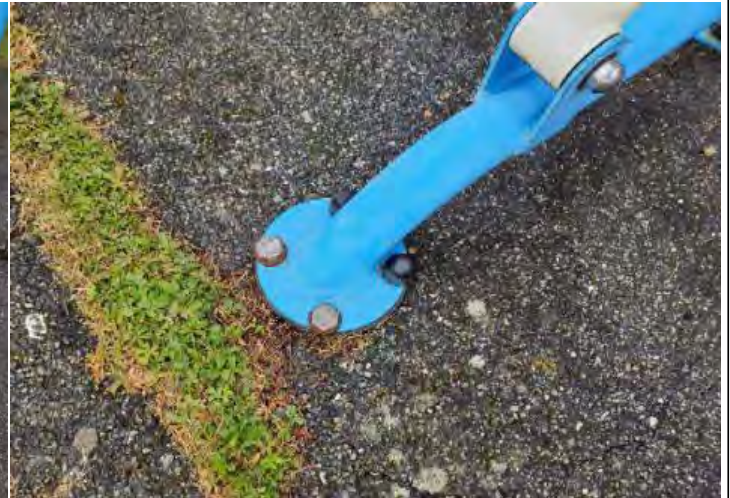
**Finding:** There is/are bolt cap covers missing or damaged on the item

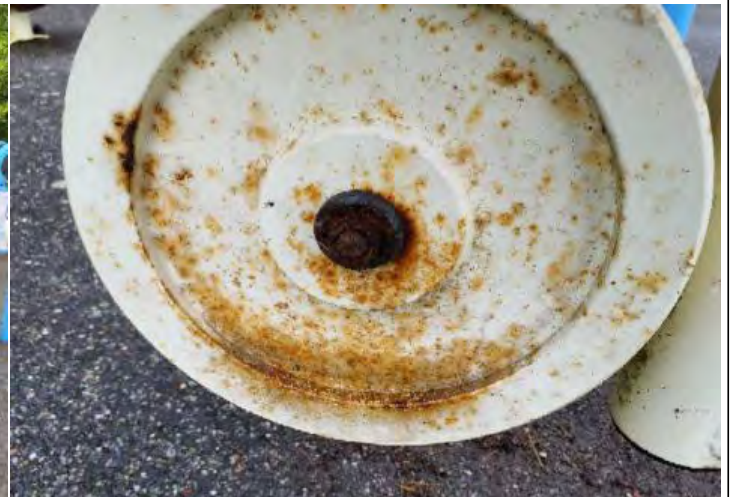
**Finding:** The fixings have corroded excessively

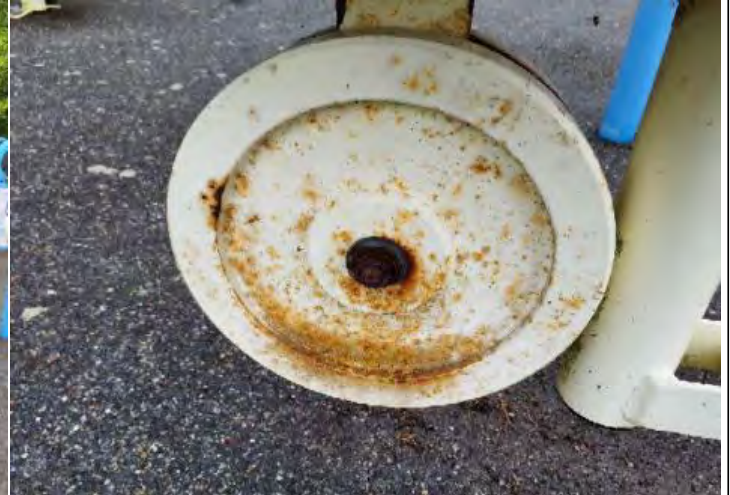
**Finding:** There is/are bolt cap covers missing or damaged on the item

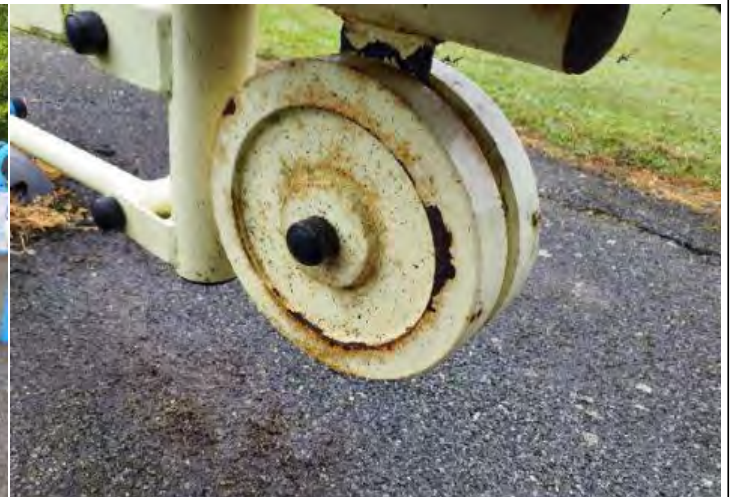
**Finding:** The paintwork on this item has been damaged or worn exposing the metal underneath which is rusting

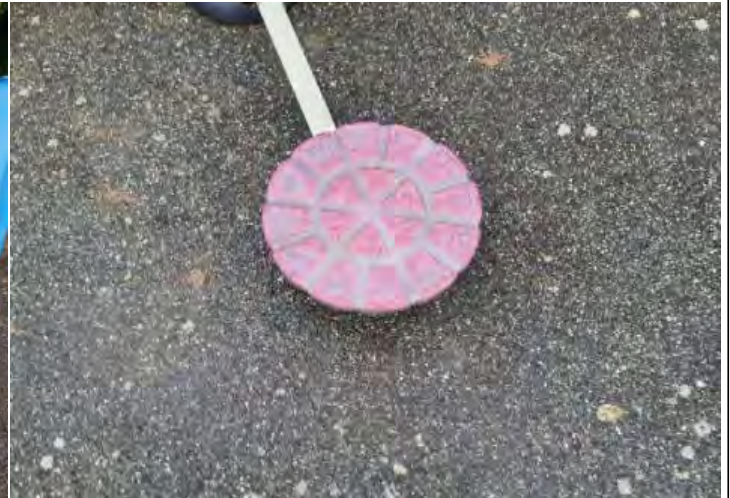
**Finding:** The rotating user station is not appropriately marked with a guideline of user direction and/or the original position as required by BS EN 16630

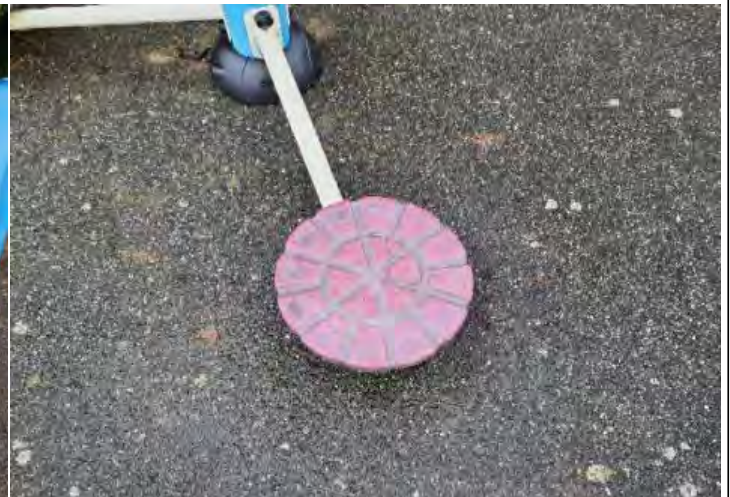
**Finding:** The deflection of the rotating user station exceeds the maximum 105 degrees required by BS EN 16630

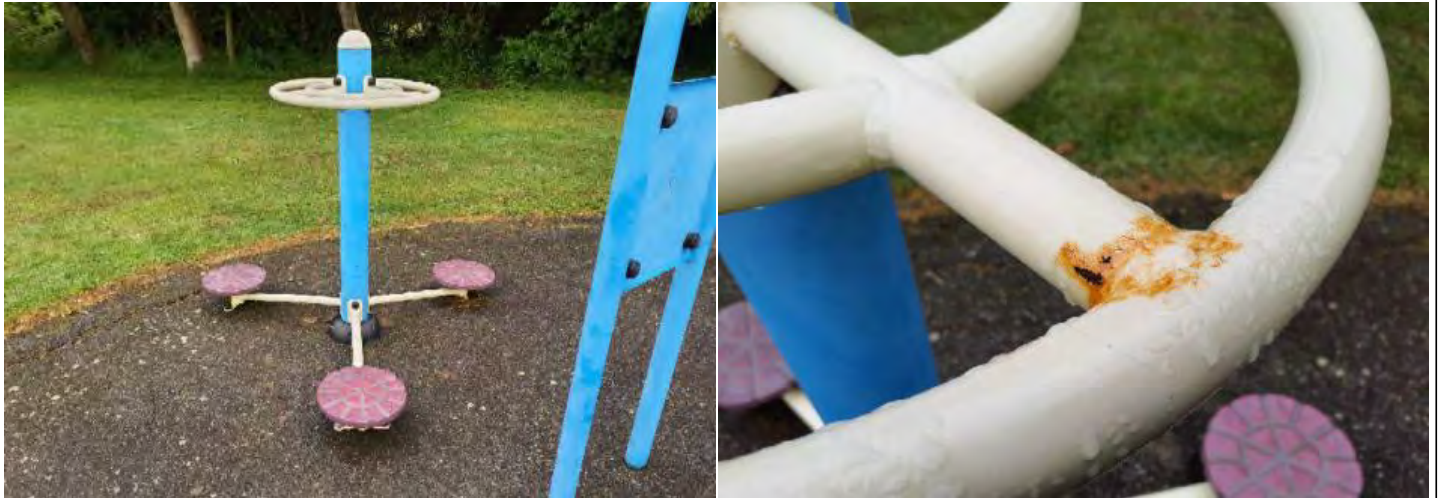
**Finding:** The paintwork on this item has been damaged or worn exposing the metal underneath which is rusting  
**Action:** Treat any rusting components and repaint

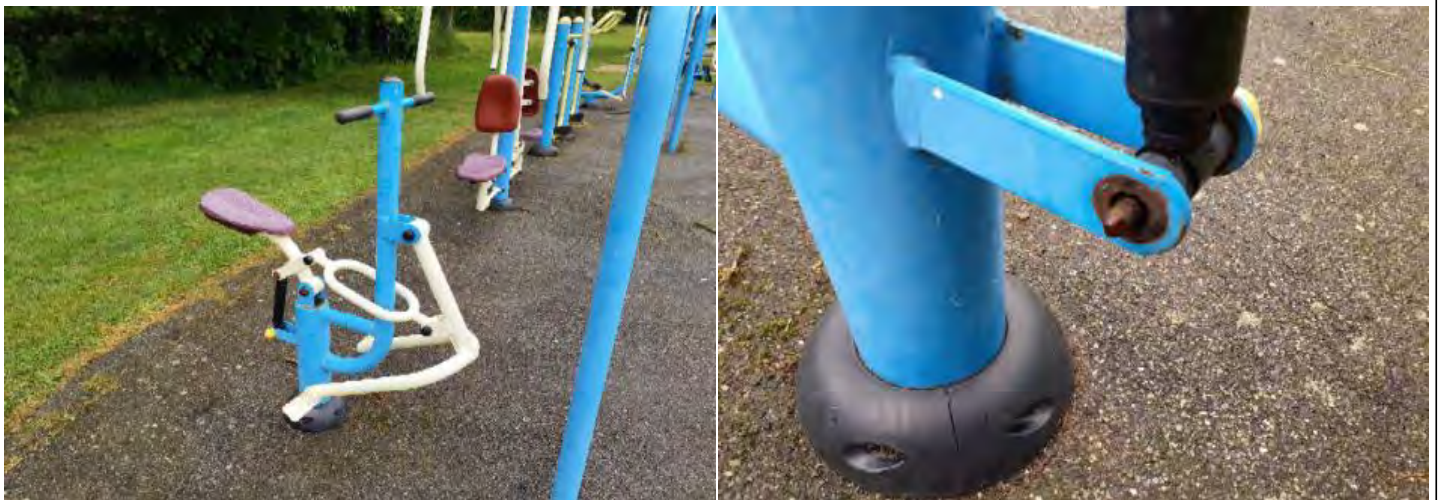
**Finding:** There is or are fixings missing on the item  
**Action:** Replace all missing fixings

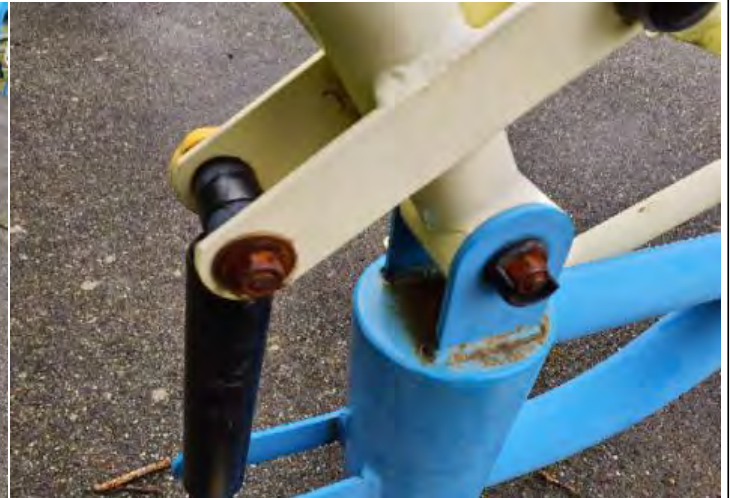
**Finding:** There is/are bolt cap covers missing or damaged on the item

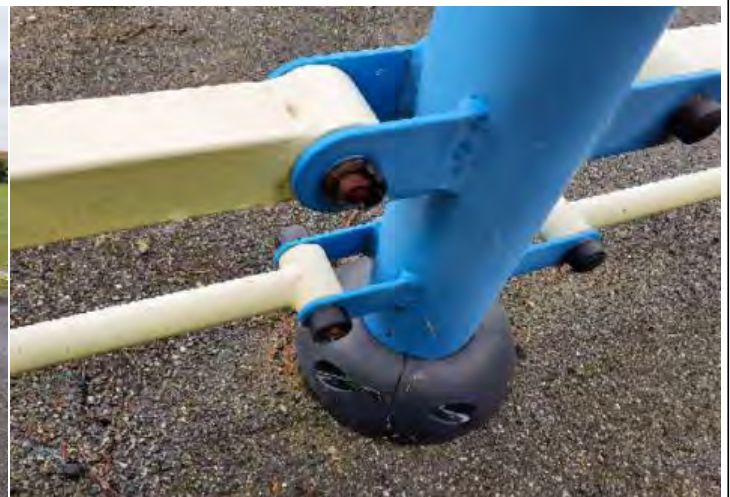
**Finding:** There is/are bolt cap covers missing or damaged on the item

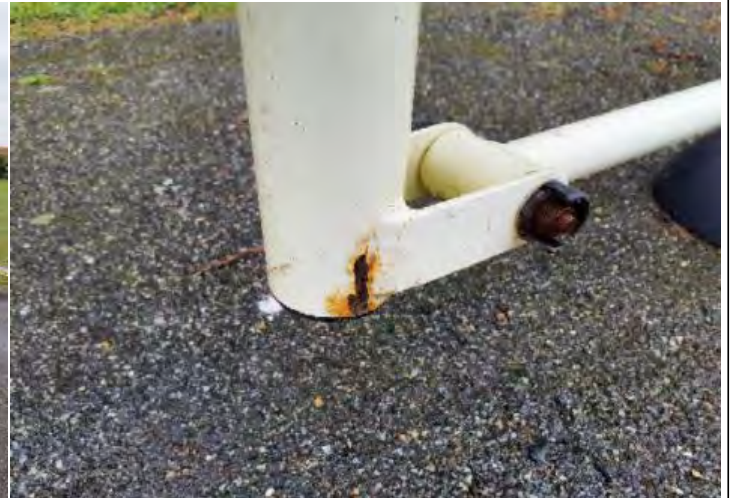
**Finding:** The paintwork on this item has been damaged or worn exposing the metal underneath which is rusting **Action:** Treat any rusting components and repaint

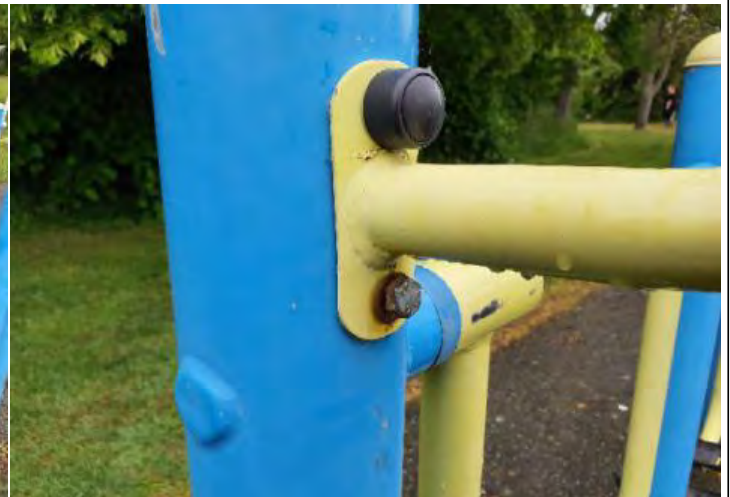
**Finding:** A number of fixing(s) have worked loose **Action:** Secure all loose fixings

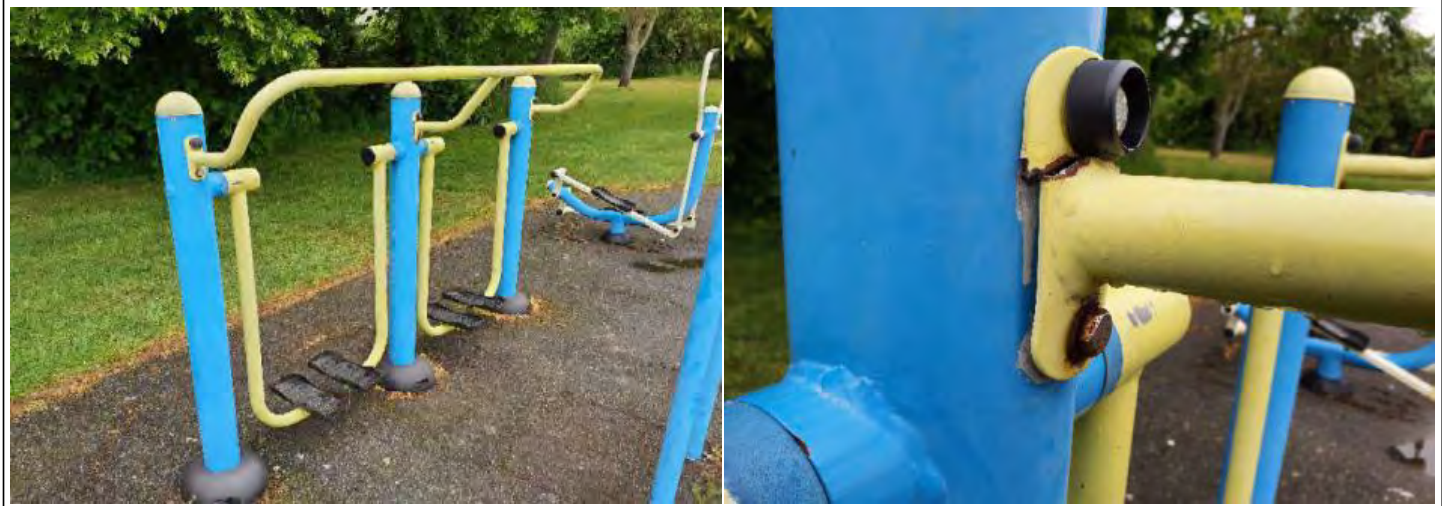
**Finding:** The weld(s) on this item have failed      **Action:** Repair item

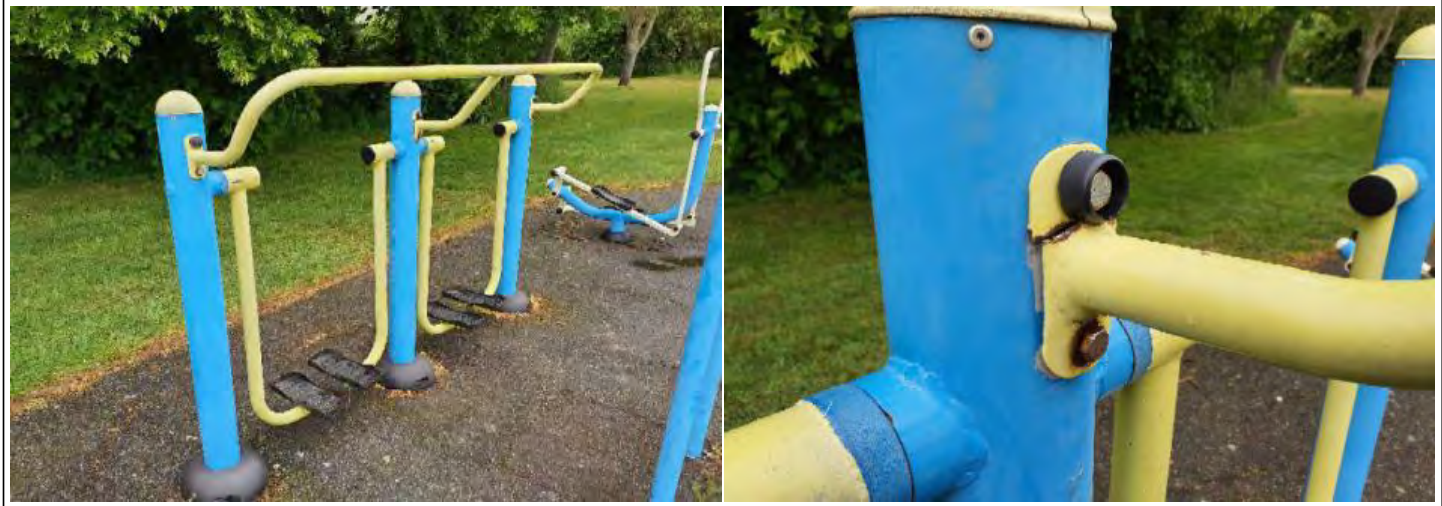
**Finding:** There is/are bolt cap covers missing or damaged on the item      **Action:** Replace missing or damaged bolt cap covers

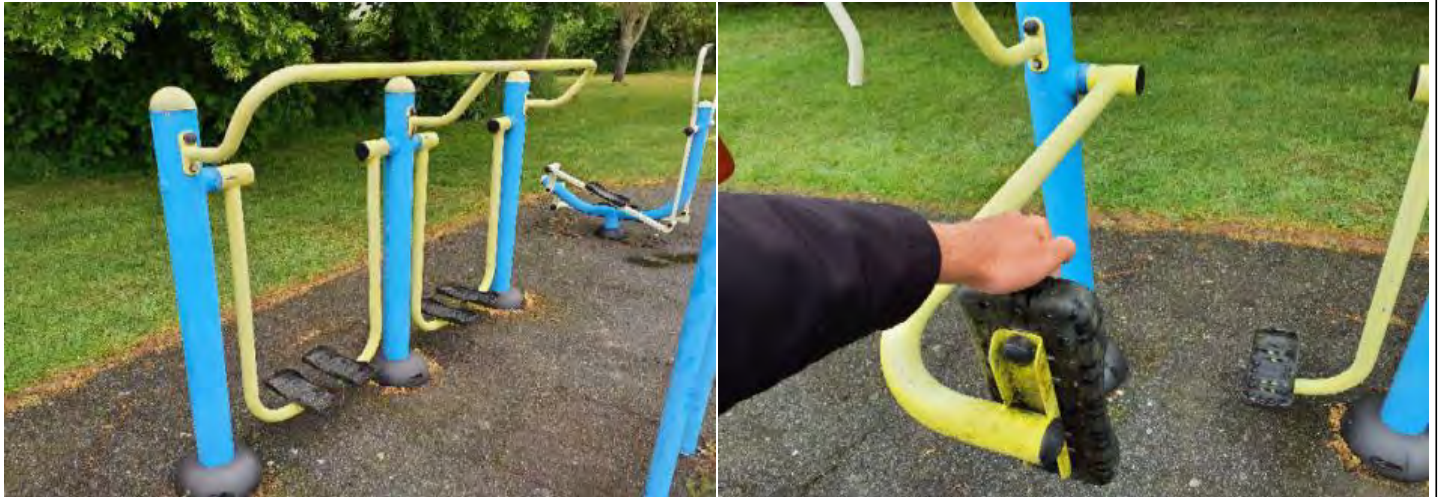
**Finding:** The swinging movement of the item exceeds the maximum 55 degrees from the vertical required by BS EN 16630

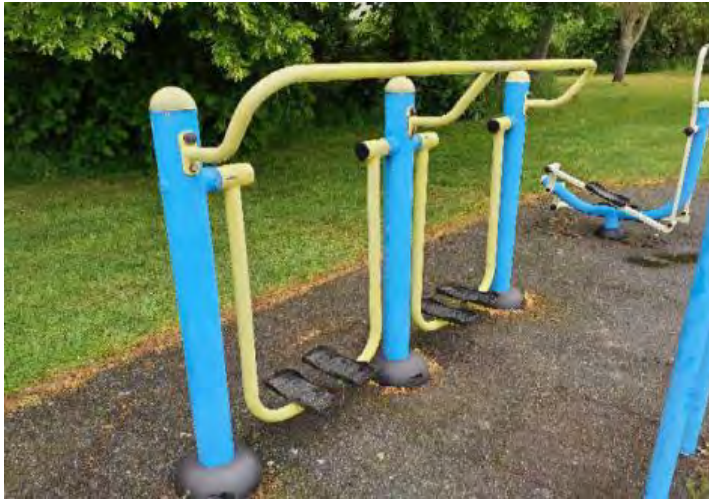
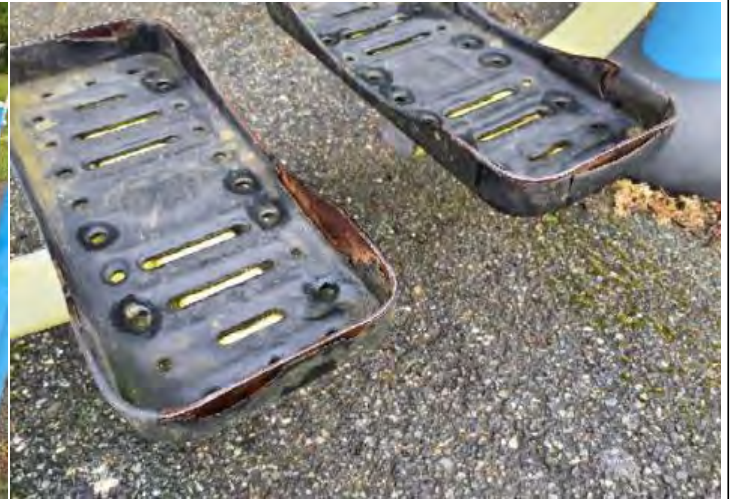
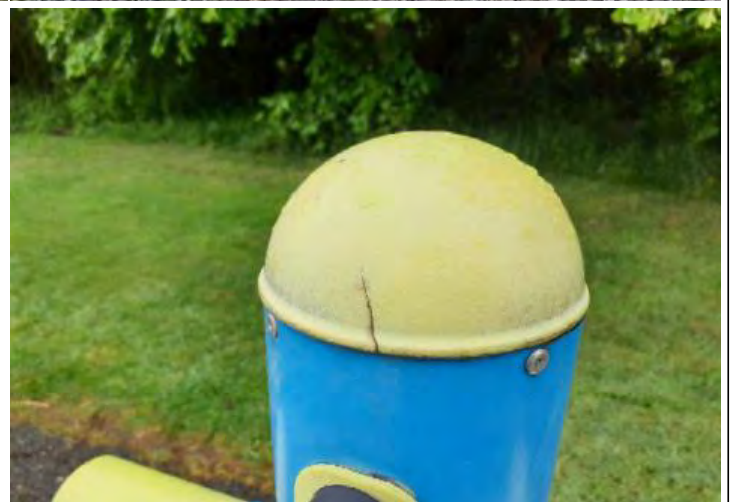
**Finding:** There is some damage to the item
