# TOLLESHUNT D'ARCY PARISH COUNCIL

## AGENDA

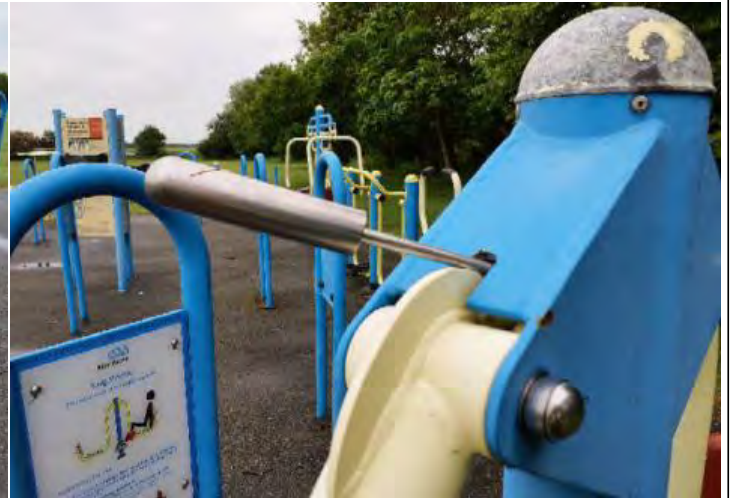
**Finding:** There are gaps between 8 and 60mm creating a potential crush/shear point in contravention of the requirements of BS EN 16630  
**Action:** Monitor - No remedial work recommended

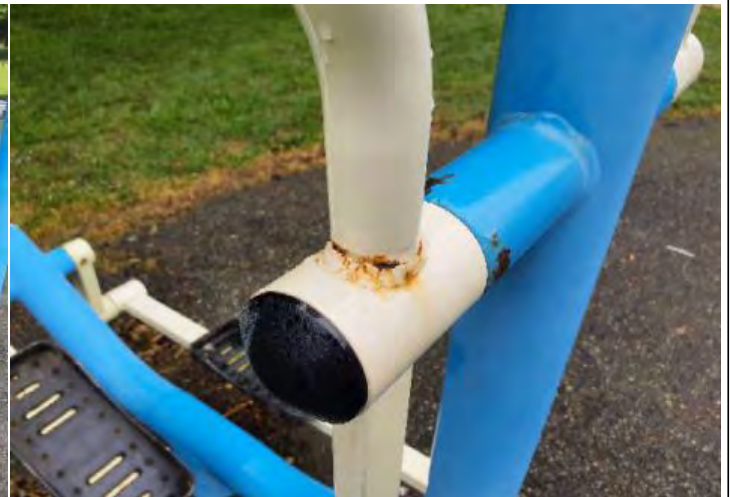
**Finding:** The paintwork on this item has been damaged or worn exposing the metal underneath which is rusting  
**Action:** Treat any rusting components and repaint

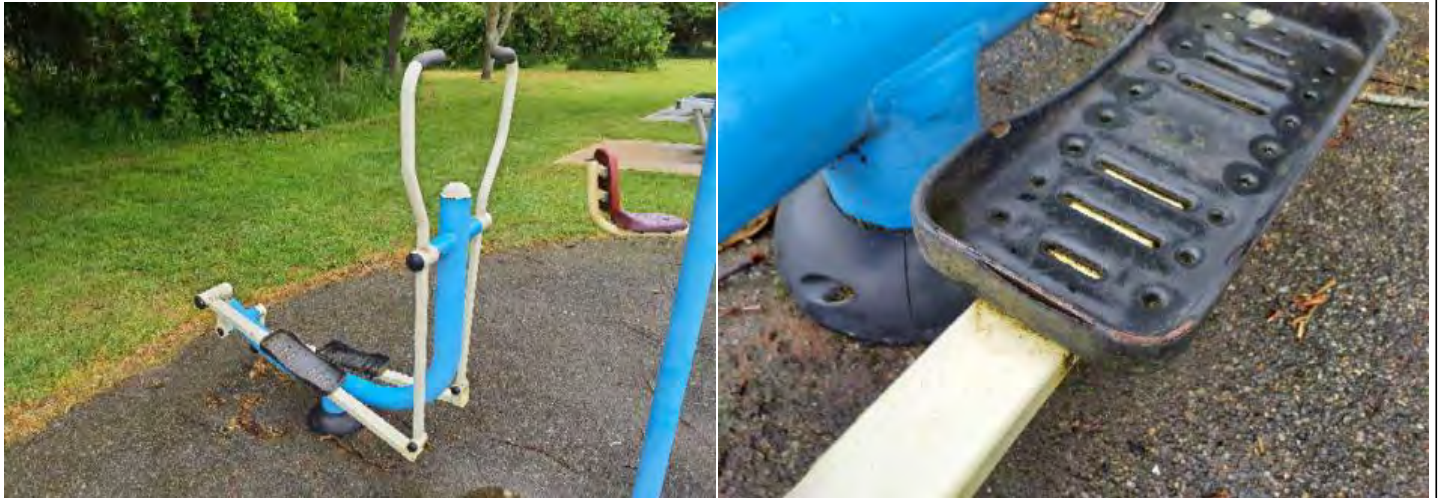
**Finding:** There is some damage to the item

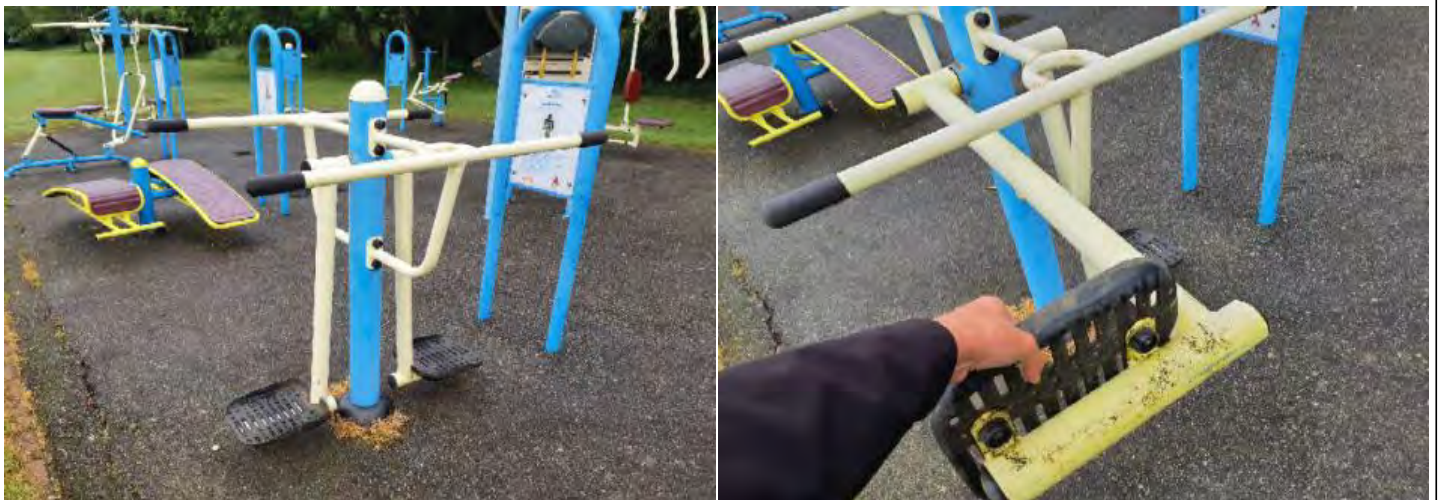
**Finding:** The swinging movement of the item exceeds the maximum 55 degrees from the vertical required by BS EN 16630

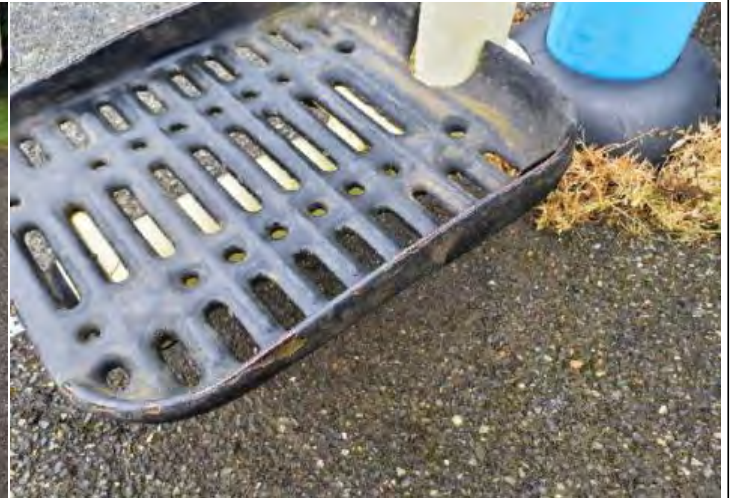
**Finding:** There is some damage to the item

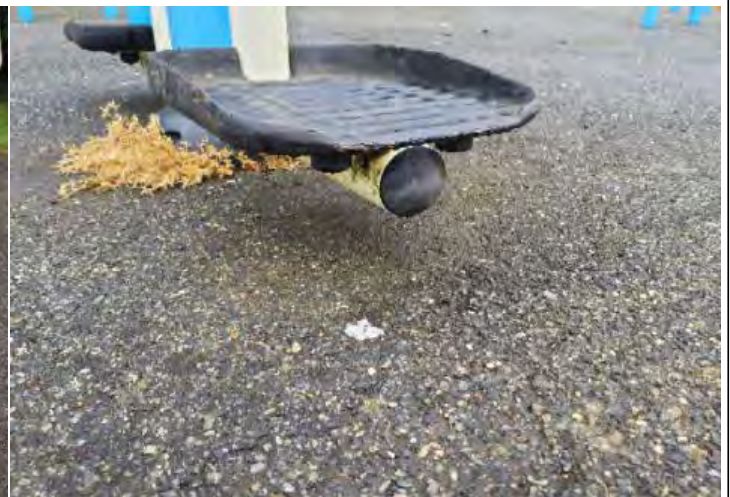
**Finding:** The distance between the underside of the item and the ground is less than the 60mm required by BS EN 16630

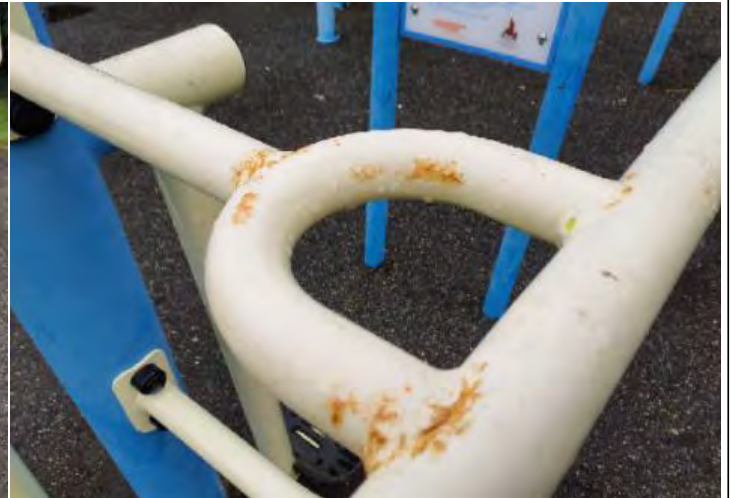
**Finding:** The paintwork on this item has been damaged or worn exposing the metal underneath which is rusting

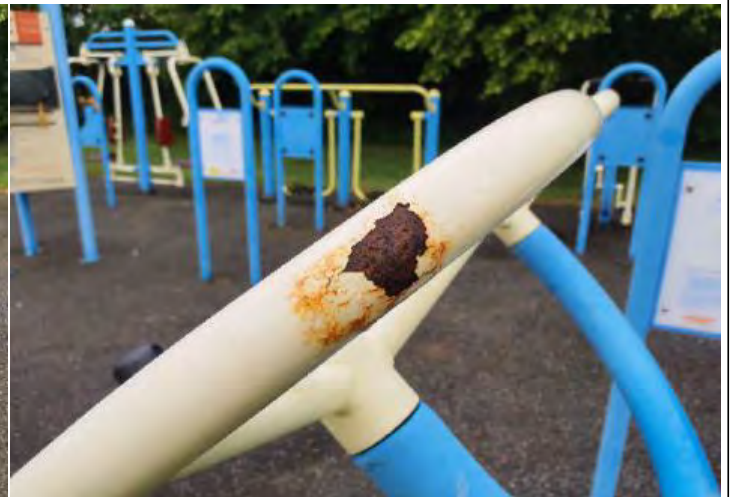
**Finding:** The paintwork on this item has been damaged or worn exposing the metal underneath which is rusting

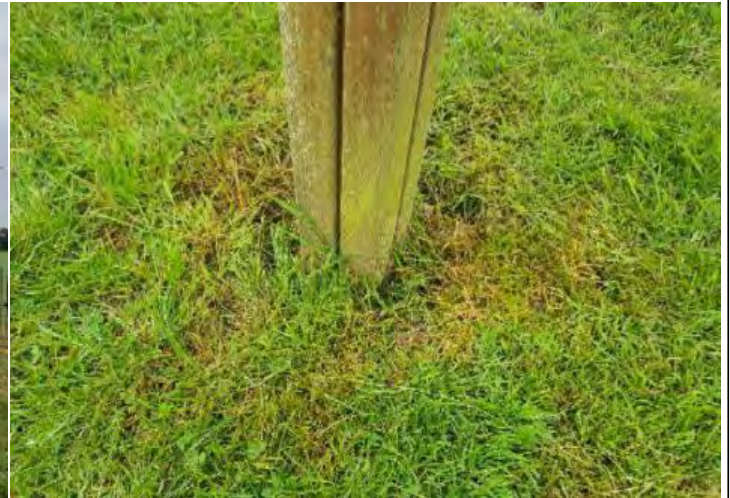
**Finding:** There is some strimmer / machinery damage apparent on the posts, this can penetrate the preservative applied to the timber and accelerate the rotting process

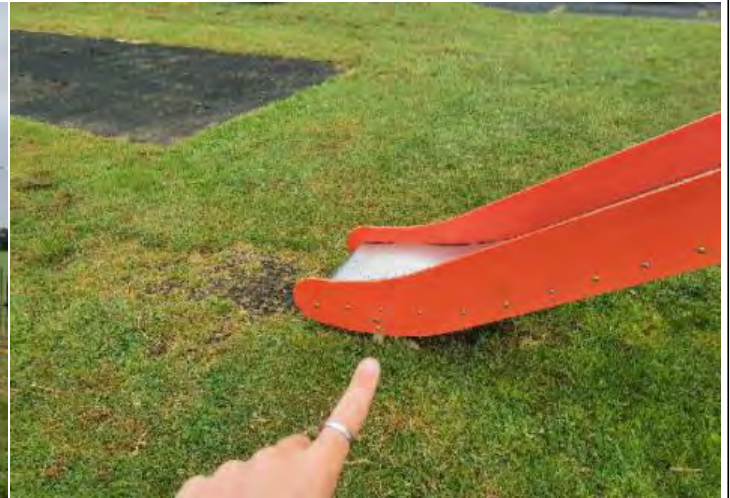
**Finding:** The item is slightly loose in its foundations

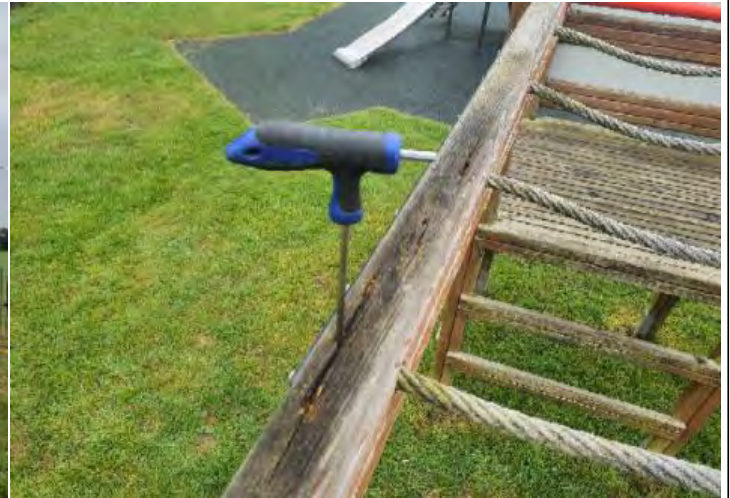
**Finding:** There is some evidence of rot in the timber

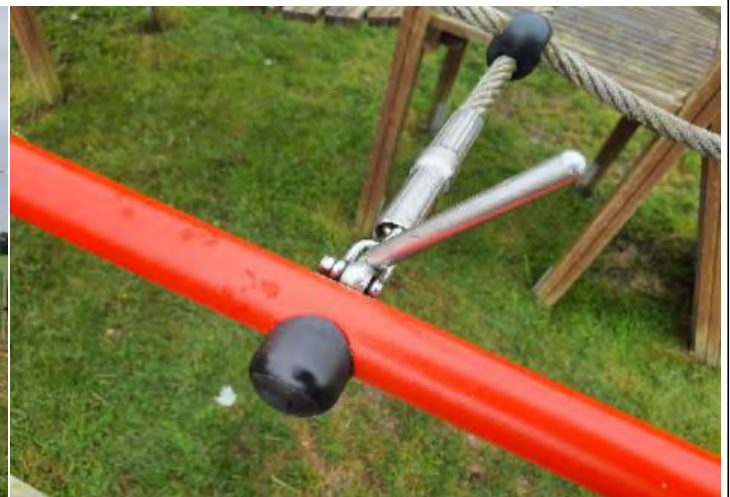
**Finding:** The connecting links are in excess of 8.6mm and less than 12mm and fail the requirements of BS EN 1176 Part 1; clause 4.2.13, Chains

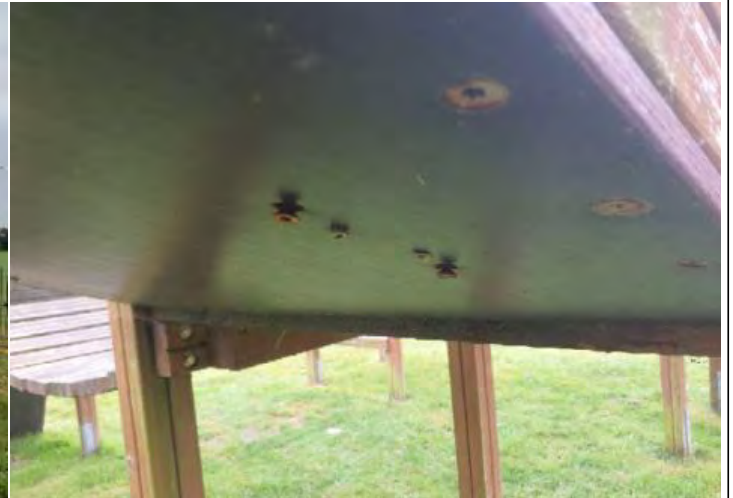
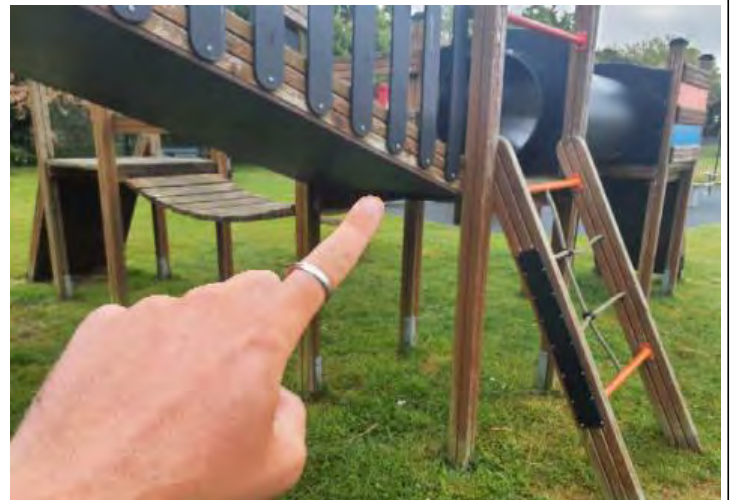
**Finding:** A number of fixing(s) have worked loose

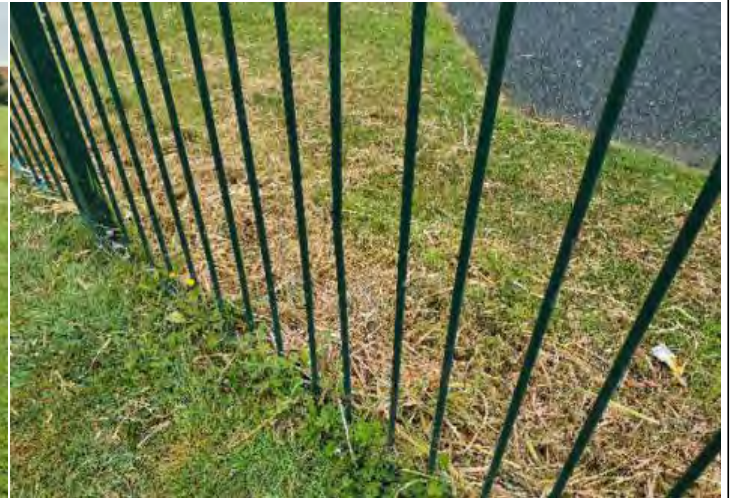
<b>Finding:</b> There is some damage to the fence sections	<b>Action:</b> Monitor for any further deterioration and repair as required
--	---

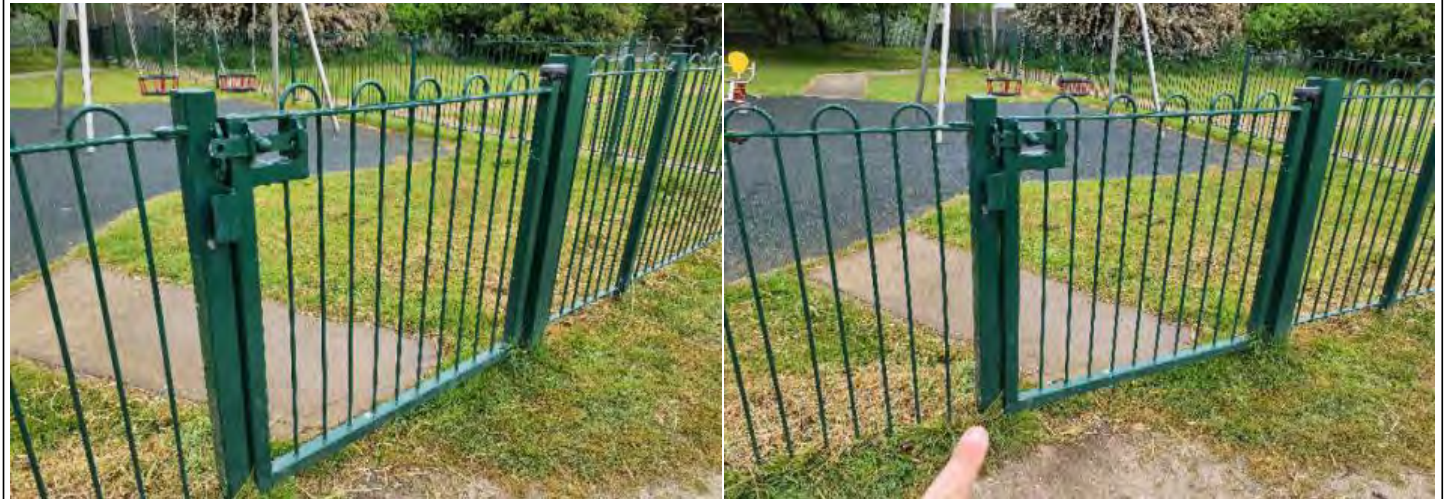
<b>Finding:</b> The item is slightly loose in its foundations	<b>Action:</b> Monitor for any further deterioration and repair as required
---	---

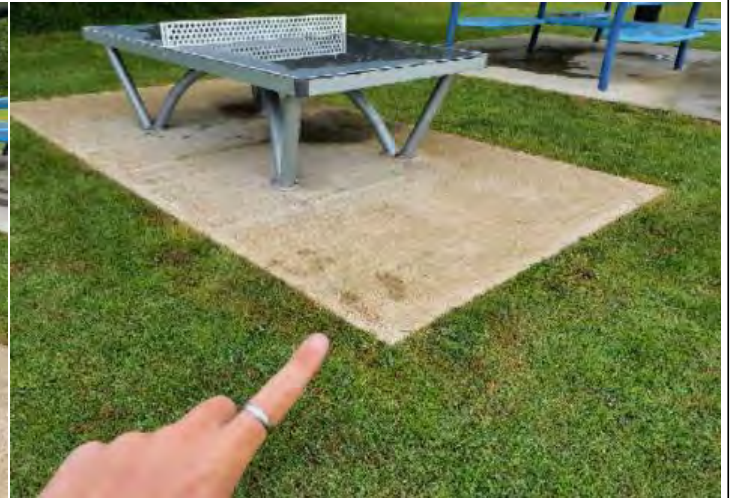
**Finding:** There are trip hazards at the edges of the surface
