# TOLLESHUNT D'ARCY PARISH COUNCIL

## AGENDA

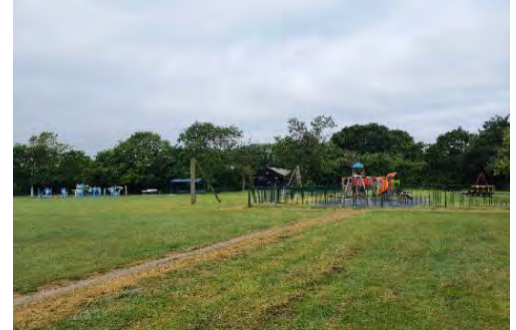
**Item:** Site General  
**Manufacturer:** Owner/Operator  
**Surface Type:** N/A  
**Item Quantity:** 1  
**Equipment Compliance:** N/A  
**Surface Area Compliance:** N/A

There are obstacles located within the movement space of the equipment in contravention of BS EN 16630 - Monitor use and review risk assessment regularly

The training space of the fitness items overlap in contravention of the requirements of BS EN 16630 - Monitor - No remedial work recommended

There is some minor damage to the surface - Monitor for any further deterioration and repair as required

It is recommended that signage, with information including the site address, contact information for maintenance issues and emergency contact details are provided for the facility - Provide in accordance with the recommendations

The tiles on the unused base are damaged - Consider the removal of the unused base

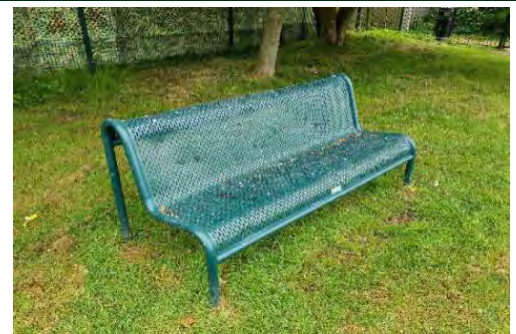
**Item:** Bench  
**Manufacturer:** Owner/Operator  
**Surface Type:** N/A  
**Item Quantity:** 1  
**Equipment Compliance:** N/A  
**Surface Area Compliance:** N/A

There is some graffiti present - Remove the graffiti

There is some damage to the item - Monitor for any further deterioration and repair as required

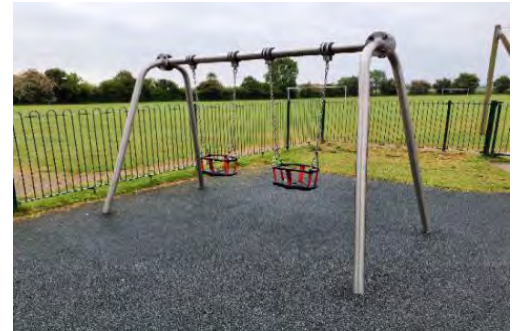
**Item:** 1 Bay 2 Seat (Cradle)  
**Manufacturer:** Playdale Playgrounds Ltd  
**Surface Type:** Wet Pour  
**Item Quantity:** 1  
**Equipment Compliance:** Yes  
**Surface Area Compliance:** No

There is/are bolt cap covers missing or damaged on the item - Replace missing or damaged bolt cap covers

The seat has minor damage or wear - Monitor for any further deterioration and replace as required

The timber edge forms a hard object within the impact area of the equipment in contravention of the requirements of BS EN 1176 Part 1 - Monitor - No remedial work recommended

There is some notable evidence of chain wear - Monitor for any further deterioration and replace when 40% worn

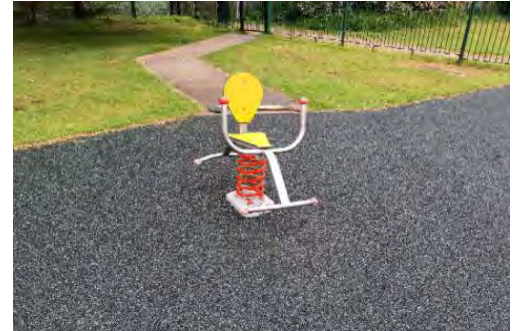
**Item:** Misc Springer  
**Manufacturer:** Playdale Playgrounds Ltd  
**Surface Type:** Wet Pour  
**Item Quantity:** 1  
**Equipment Compliance:** Yes  
**Surface Area Compliance:** Yes

The spring clamps are loose - Tighten all loose fixings

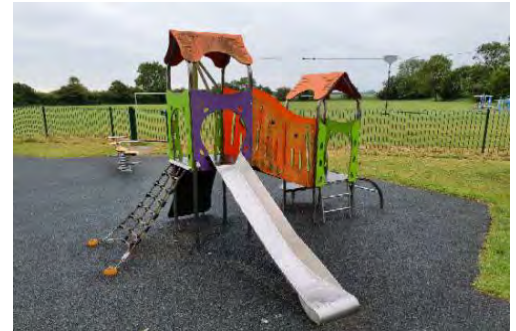
**Item:** Multi Play (Toddler)  
**Manufacturer:** Playdale Playgrounds Ltd  
**Surface Type:** Wet Pour  
**Item Quantity:** 1  
**Equipment Compliance:** Yes  
**Surface Area Compliance:** Yes

The ropes/nets are worn/damaged in places - Monitor for any further deterioration and repair or replace as required

There is/are bolt cap covers missing or damaged on the item - Replace missing or damaged bolt cap covers

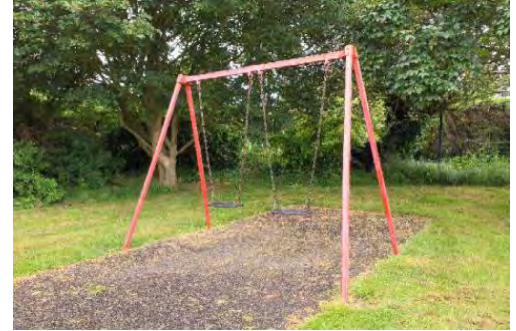
**Item:** 1 Bay 2 Seat (Flat)  
**Manufacturer:** Record RSS  
**Surface Type:** Bonded Rubber Mulch  
**Item Quantity:** 1  
**Equipment Compliance:** No  
**Surface Area Compliance:** Yes

The chain openings are in excess of 8.6mm and do not meet the recommendations of BS EN 1176 Part 1 - Monitor - No remedial work recommended

There is some notable evidence of chain wear - Monitor for any further deterioration and replace when 40% worn

There is some wear to the shackles - Monitor for any further deterioration and replace when 40% worn

The seat has minor damage or wear - Monitor for any further deterioration and replace as required

The seats are too close to each other as defined in BS EN 1176 Part 2; this is a low risk failure and no remedial action is required - Monitor - No remedial work recommended

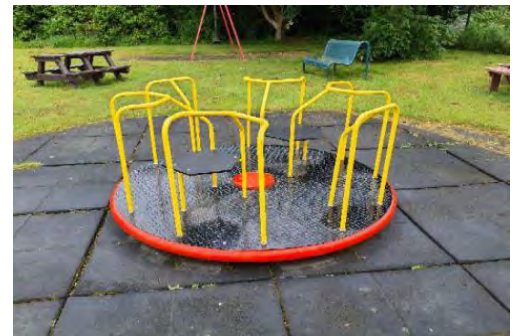
**Item:** Roundabout  
**Manufacturer:** Wicksteed Playgrounds  
**Surface Type:** Rubber Tiles  
**Item Quantity:** 1  
**Equipment Compliance:** Yes  
**Surface Area Compliance:** Yes

There are gaps opening in between the tiles - Monitor for any further deterioration and repair as required

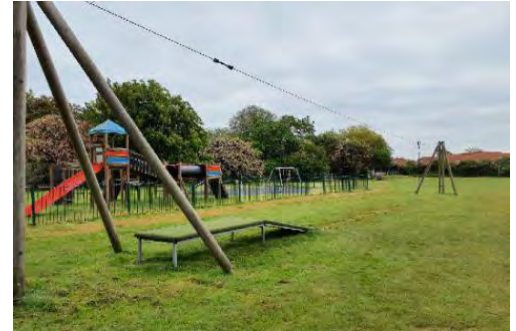
**Item:** Cable Runway  
**Manufacturer:** Playdale Playgrounds Ltd  
**Surface Type:** Grass Matrix Tiles  
**Item Quantity:** 1  
**Equipment Compliance:** Yes  
**Surface Area Compliance:** Yes

We have completed a visual inspection of the suspension links, cable and fixing points from ground level, however it is not possible to fully inspect these areas without either hiring equipment to gain access or removing the cable and suspension and inspecting at ground level. We recommend that the main cable and fixing security is thoroughly inspected at least in accordance with the manufacturers recommendations to check for wear, damage, security or internal rusting; this will help to ensure the continued safe use of the equipment - Inspect in accordance with the manufacturers recommendations

There is some notable evidence of chain wear - Monitor for any further deterioration and replace when 40% worn

The cableway seat has been damaged - Monitor for any further deterioration and replace as required

The timber has a number of splits/shakes or air cracks and this may affect the stability or allow water ingress which will accelerate the rotting process - Monitor to ensure the splits do not cross through fixing points of the structure and/or cause any instability

The grass mats are silted up and the soil is compacted; this may have an effect on the impact absorbing properties of the surface - Consider HIC testing impact absorbing properties to ensure the correct surface qualities are maintained for the equipment and replace as required

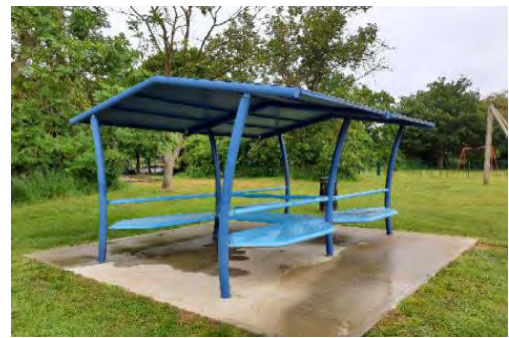
**Item:** Shelter  
**Manufacturer:** Not Identified  
**Surface Type:** Concrete  
**Item Quantity:** 1  
**Equipment Compliance:** N/A  
**Surface Area Compliance:** N/A

**Finding 1**  
 There are trip hazards at the edges of the surface - Reinstate surrounding surface levels to remove the trip points

**Finding 2**  
 There are projecting bolt thread(s) present - Remove excess thread length and deburr or provide cap

**Finding 4**  
 There is or are fixings missing on the item - Replace all missing fixings

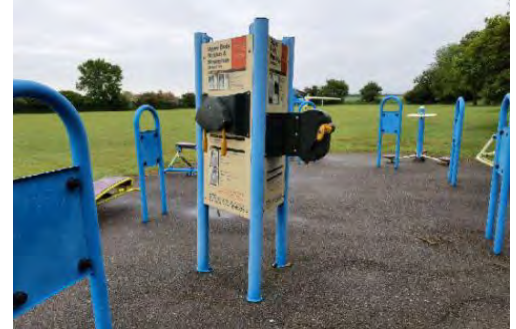
**Item:** Fit Point  
**Manufacturer:** Playworld Systems (Europe) Ltd  
**Surface Type:** Bitmac  
**Item Quantity:** 1  
**Equipment Compliance:** Yes  
**Surface Area Compliance:** Yes

There is or are fixings missing on the item - Replace all missing fixings

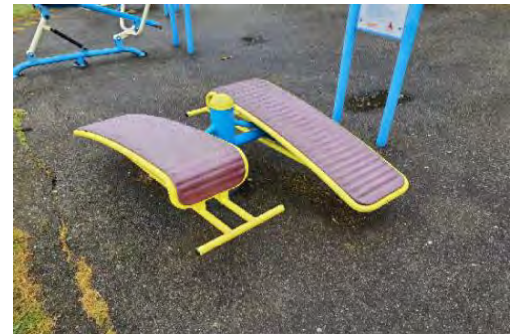
**Item:** Ab Station  
**Manufacturer:** Playworld Systems (Europe) Ltd  
**Surface Type:** Bitmac  
**Item Quantity:** 1  
**Equipment Compliance:** Yes  
**Surface Area Compliance:** Yes

The paintwork on this item has been damaged or worn exposing the metal underneath which is rusting - Treat any rusting components and repaint

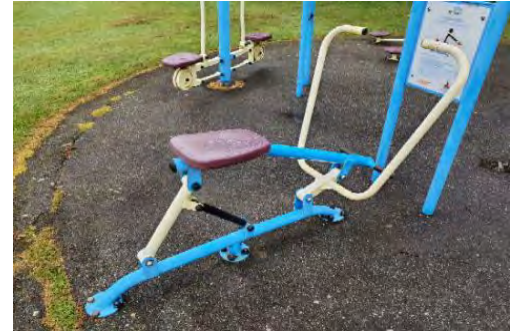
**Item:** Rower  
**Manufacturer:** Playworld Systems (Europe) Ltd  
**Surface Type:** Bitmac  
**Item Quantity:** 1  
**Equipment Compliance:** Yes  
**Surface Area Compliance:** Yes

There is/are bolt cap covers missing or damaged on the item - Replace missing or damaged bolt cap covers

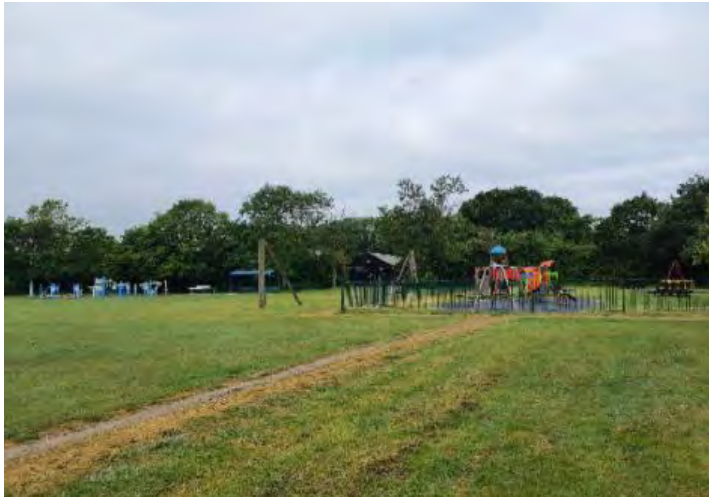
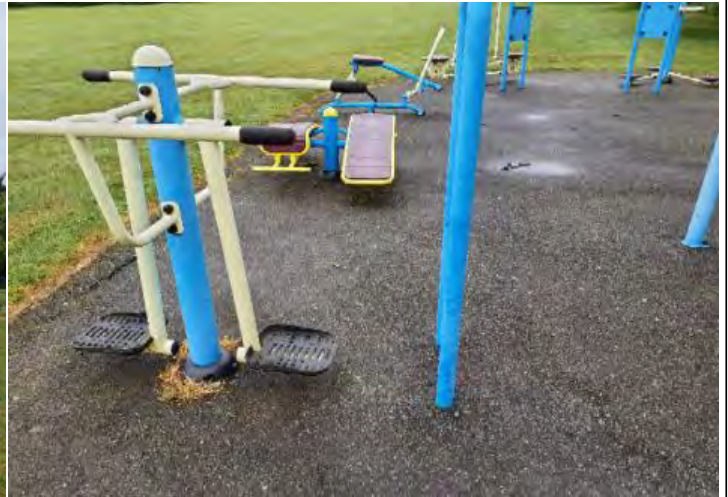
**Item:** Ancillary Items - Site General  
**Manufacturer:** Owner/Operator

**Finding:** There are obstacles located within the movement space of the equipment in contravention of BS EN 16630

**Action:** Monitor use and review risk assessment regularly

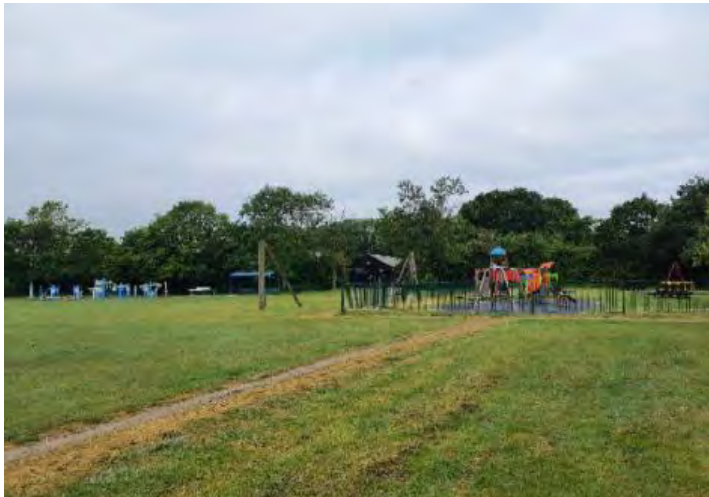
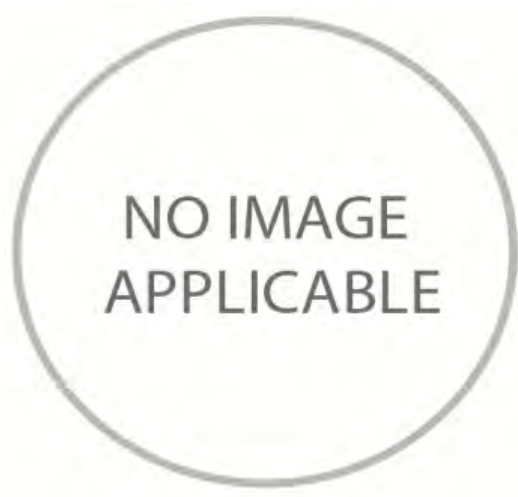
**Item:** Ancillary Items - Site General  
**Manufacturer:** Owner/Operator  
**Risk Level:** V - Very Low Risk  
**Surface:** N/A

**Finding:** It is recommended that signage, with information including the site address, contact information for maintenance issues and emergency contact details are provided for the facility  
**Action:** Provide in accordance with the recommendations

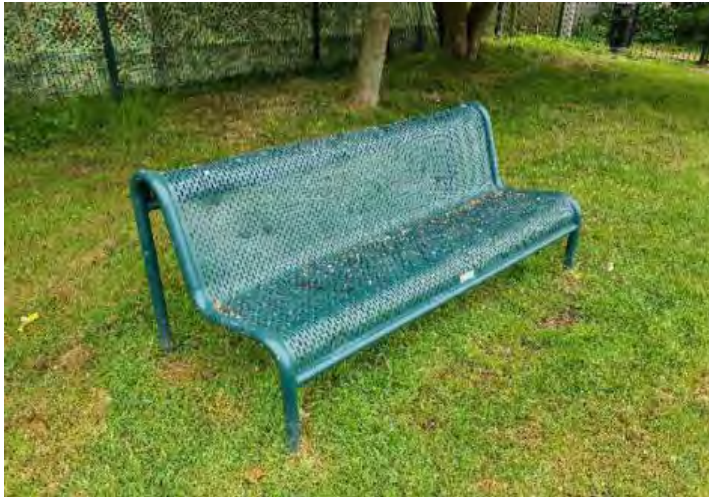
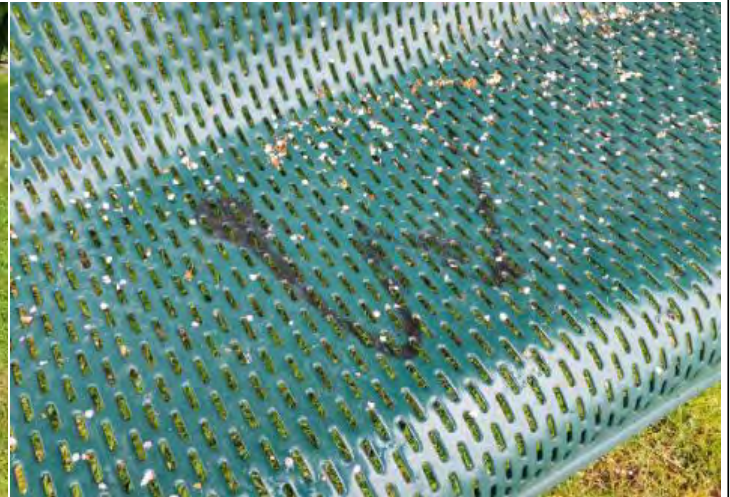
**Item:** Ancillary Items - Bench  
**Manufacturer:** Owner/Operator

**Finding:** There is some graffiti present

**Action:** Remove the graffiti

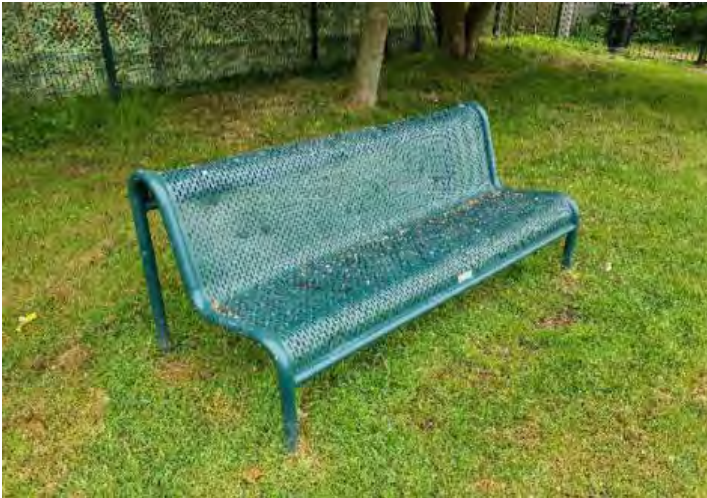
**Item:** Ancillary Items - Bench  
**Manufacturer:** Owner/Operator

**Finding:** There is some damage to the item

**Action:** Monitor for any further deterioration and repair as required

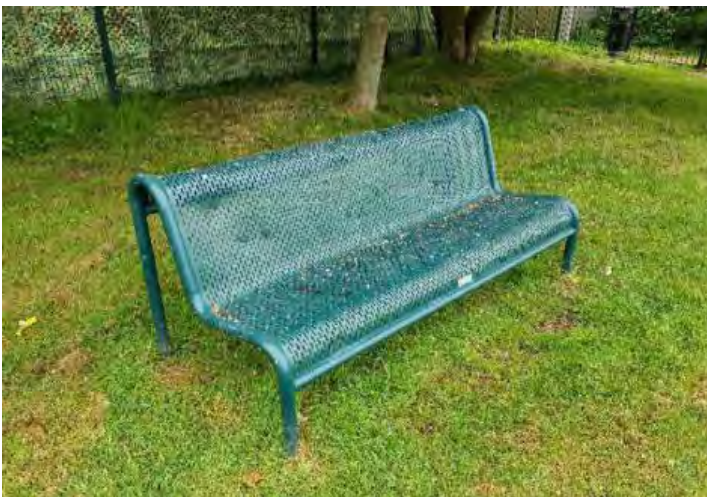
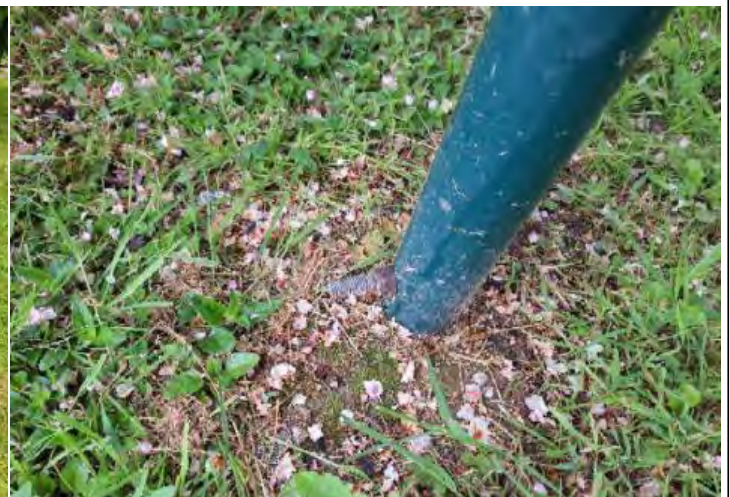
**Item:** Ancillary Items - Bench  
**Manufacturer:** Owner/Operator

**Finding:** There are projecting bolt thread(s) present

**Action:** Remove excess thread length and deburr or provide cap

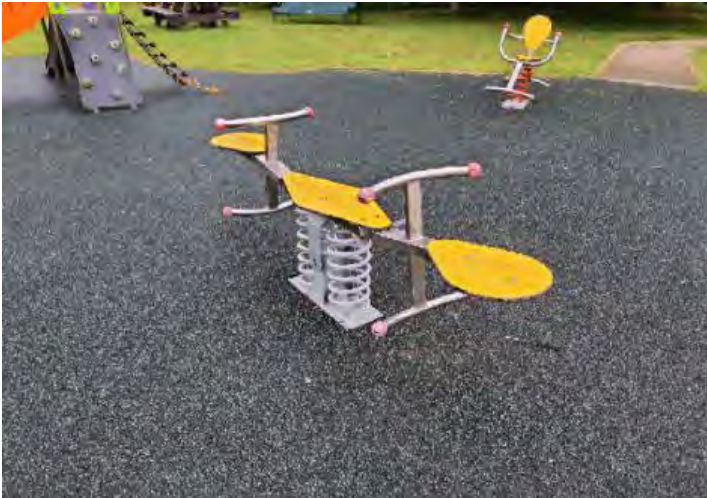
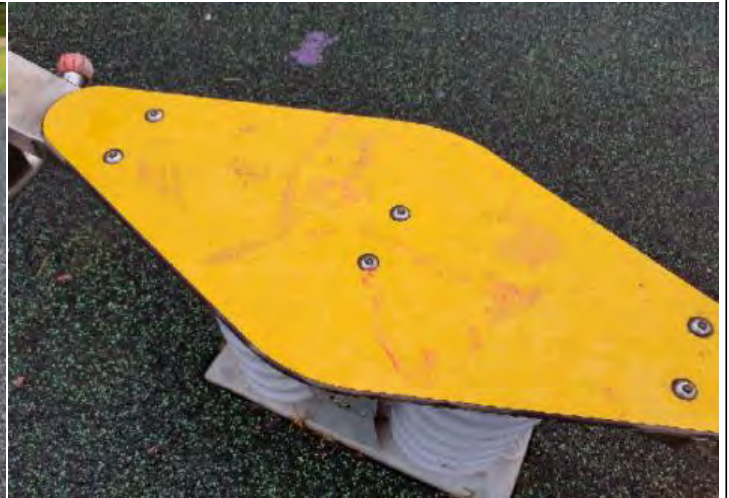
**Item:** Rocking Equipment - Spring See-Saw  
**Manufacturer:** Playdale Playgrounds Ltd

**Finding:** There is some graffiti present

**Action:** Remove the graffiti

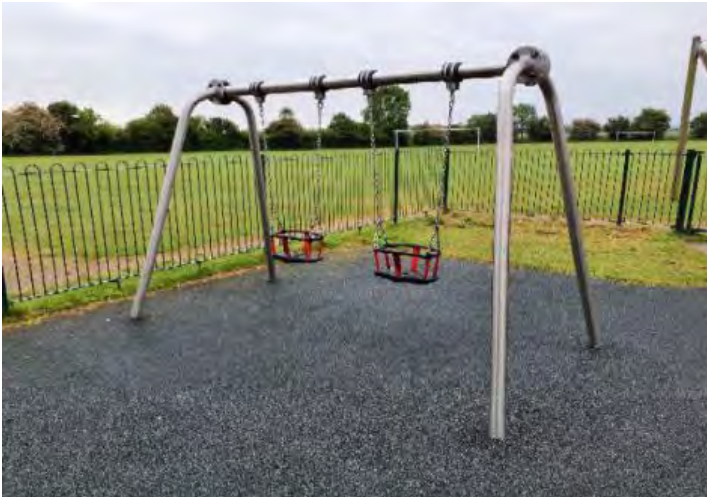
**Item:** Swings - 1 Bay 2 Seat (Cradle)  
**Manufacturer:** Playdale Playgrounds Ltd

**Finding:** There is/are bolt cap covers missing or damaged on the item

**Action:** Replace missing or damaged bolt cap covers

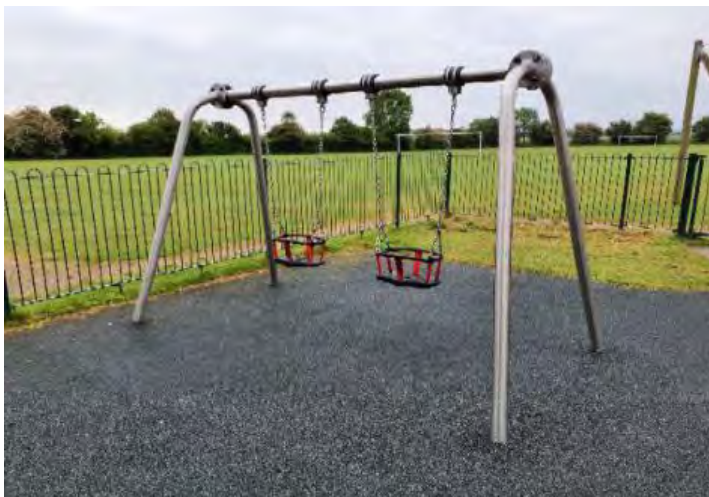
**Item:** Swings - 1 Bay 2 Seat (Cradle)  
**Manufacturer:** Playdale Playgrounds Ltd

**Finding:** The timber edge forms a hard object within the impact area of the equipment in contravention of the requirements of BS EN 1176 Part 1

**Action:** Monitor - No remedial work recommended

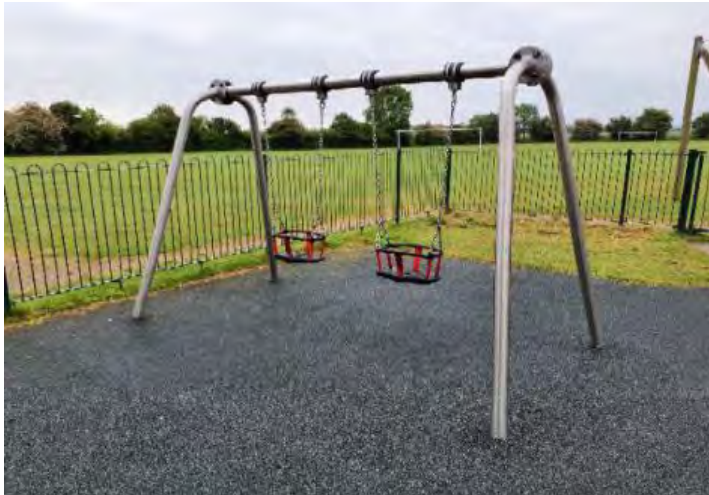
**Item:** Swings - 1 Bay 2 Seat (Cradle)  
**Manufacturer:** Playdale Playgrounds Ltd

**Finding:** There is some notable evidence of chain wear

**Action:** Monitor for any further deterioration and replace when 40% worn

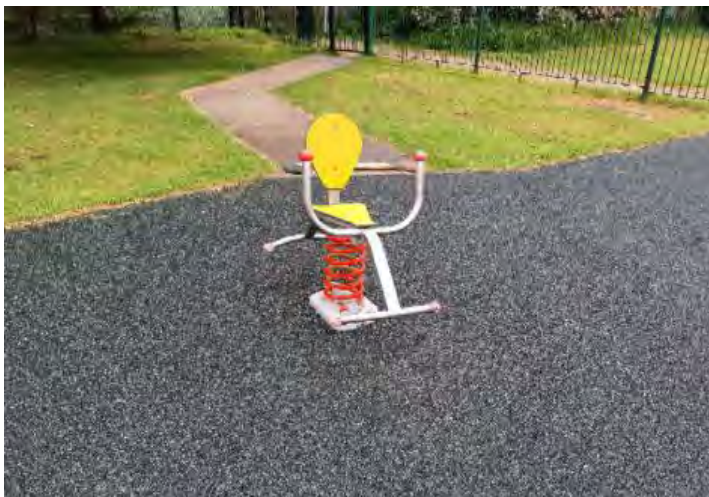
**Item:** Rocking Equipment - Misc Springer  
**Manufacturer:** Playdale Playgrounds Ltd

**Finding:** The spring clamps are loose

**Action:** Tighten all loose fixings

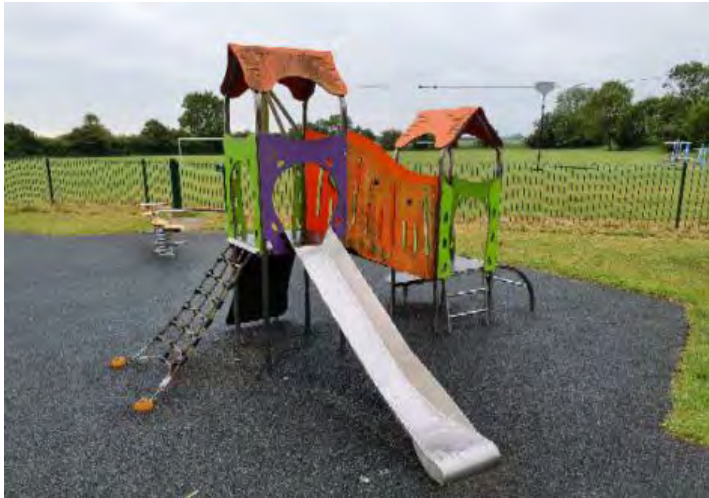
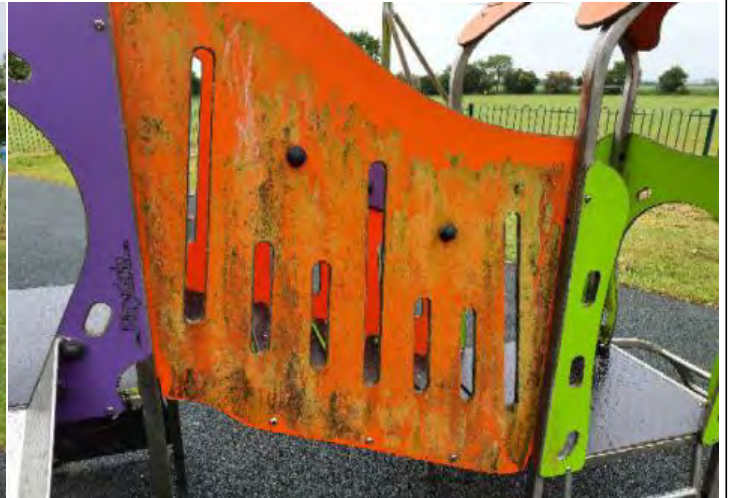
**Item:** Activity Equipment - Multi Play (Toddler)  
**Manufacturer:** Playdale Playgrounds Ltd

**Finding:** There is algae or moss on the surface of the equipment

**Action:** Clean and treat appropriately

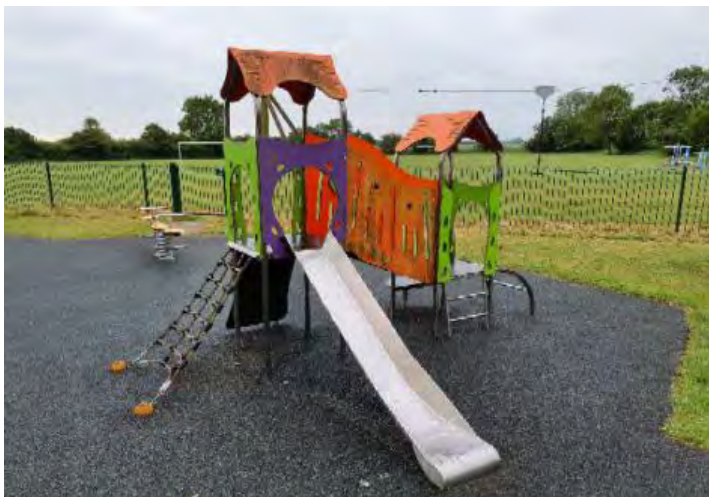
**Item:** Activity Equipment - Multi Play (Toddler)  
**Manufacturer:** Playdale Playgrounds Ltd

**Finding:** There is/are bolt cap covers missing or damaged on the item

**Action:** Replace missing or damaged bolt cap covers

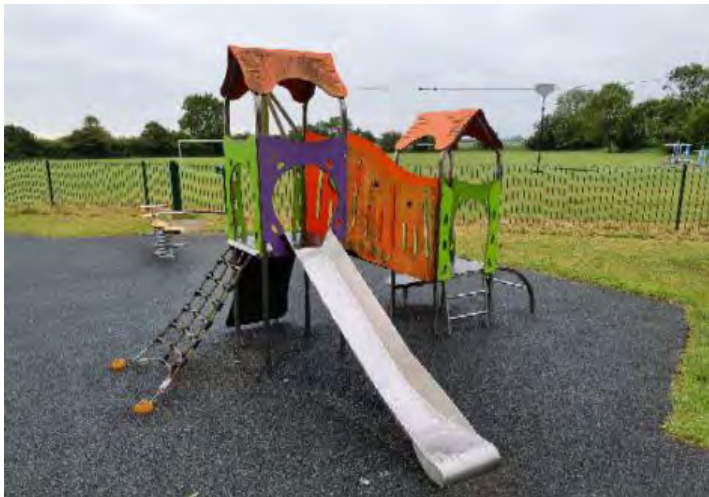
**6 - Low Risk (Finding 3)**

**Item:** Activity Equipment - Multi Play (Toddler) **Risk Level:** L - Low Risk  
**Manufacturer:** Playdale Playgrounds Ltd **Surface:** Wet Pour

**Finding:** The ropes/nets are worn/damaged in places

**Action:** Monitor for any further deterioration and repair or replace as required

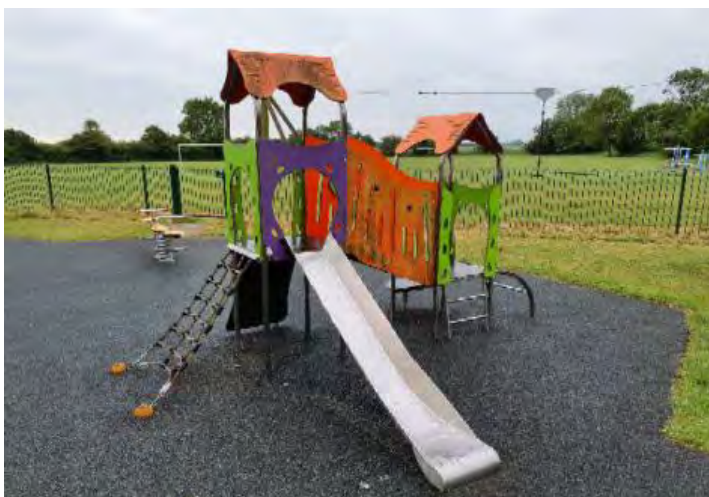
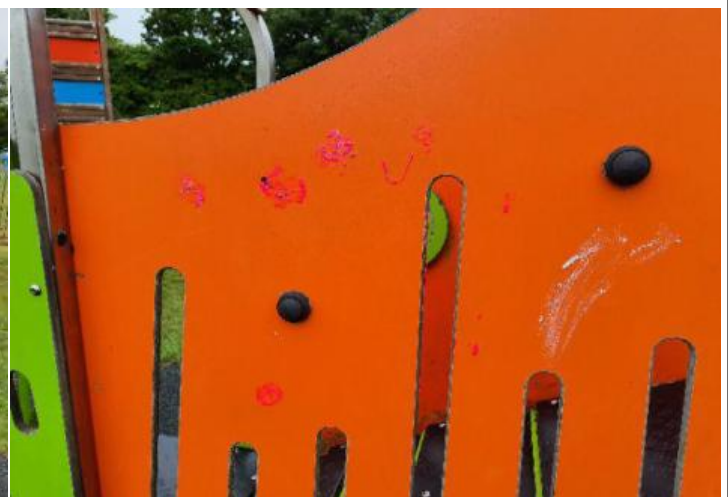
**0 - Risk Assessment not Undertaken (Finding 4)**

**Item:** Activity Equipment - Multi Play (Toddler) **Risk Level:** N - Risk Assessment not Undertaken  
**Manufacturer:** Playdale Playgrounds Ltd **Surface:** Wet Pour

**Finding:** There is some graffiti present

**Action:** Remove the graffiti

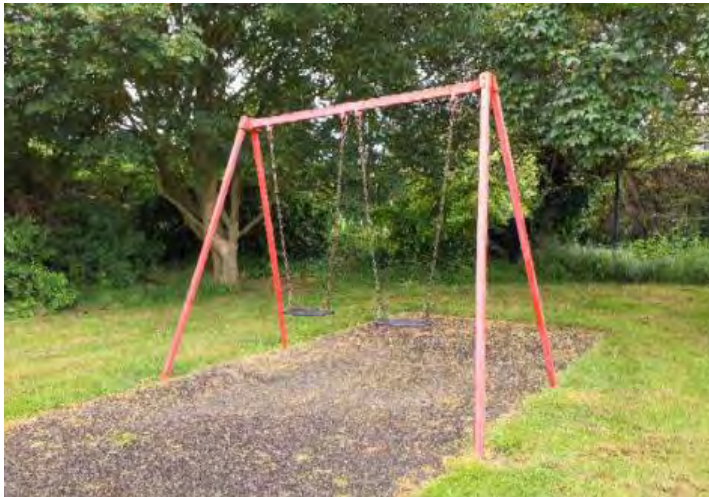
**Item:** Swings - 1 Bay 2 Seat (Flat)  
**Manufacturer:** Record RSS

**Finding:** There is some notable evidence of chain wear

**Action:** Monitor for any further deterioration and replace when 40% worn

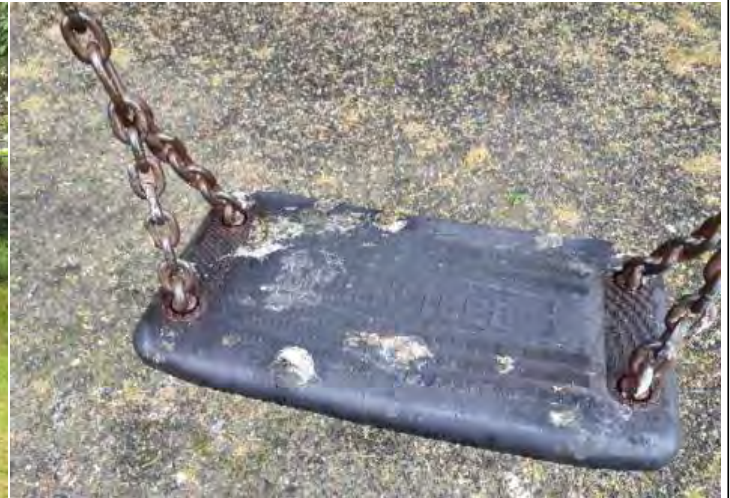
**Item:** Swings - 1 Bay 2 Seat (Flat)  
**Manufacturer:** Record RSS

**Finding:** There is an excessive amount of bird droppings on the seats  
**Action:** Clean and maintain

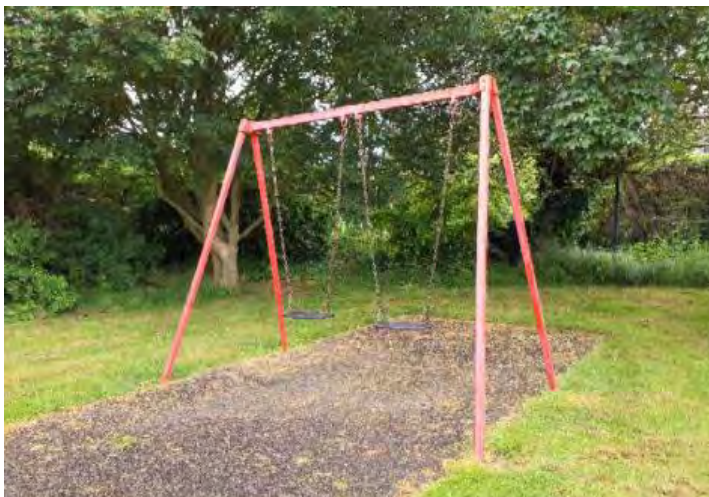
**4 - Very Low Risk (Finding 6)**

**Item:** Swings - 1 Bay 2 Seat (Flat)  
**Manufacturer:** Record RSS

**Finding:** The seats are too close to each other as defined in BS EN 1176 Part 2; this is a low risk failure and no remedial action is required  
**Action:** Monitor - No remedial work recommended

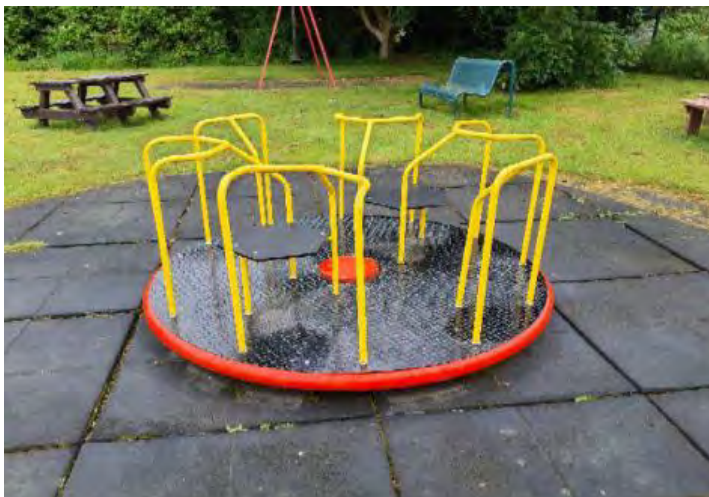
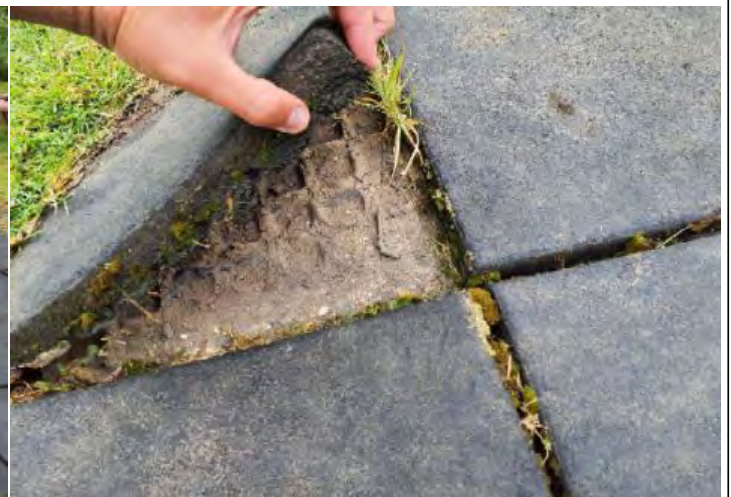
**Item:** Rotor Play - Roundabout  
**Manufacturer:** Wicksteed Playgrounds

**Finding:** The tiles can easily be lifted or are lifting along the edges of the area

**Action:** Lift and re-glue tiles to secure

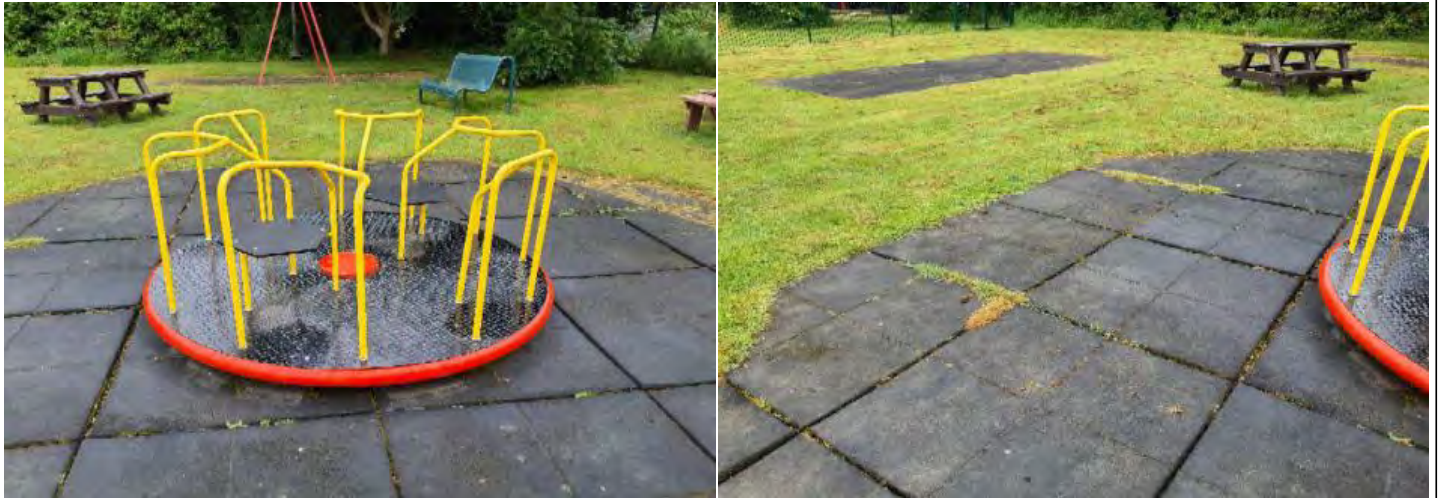
**Item:** Rotor Play - Roundabout  
**Manufacturer:** Wicksteed Playgrounds

**Finding:** There is weed / vegetation growth on, between, or around the edges of the surfacing  
**Action:** Remove weed / vegetation growth

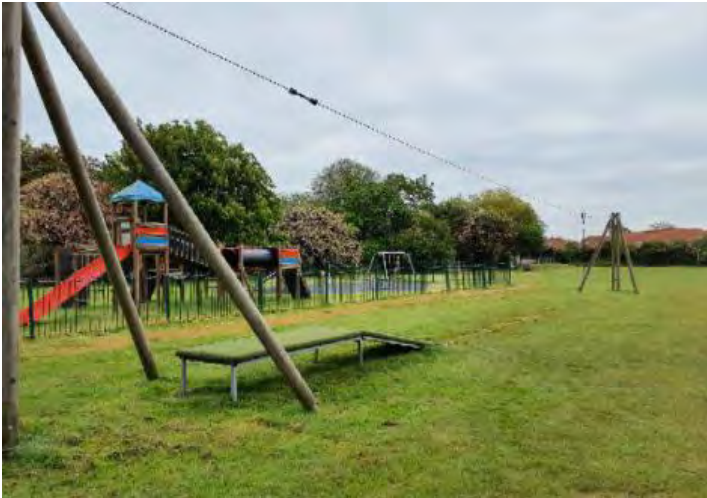
**Item:** Other - Cable Runway  
**Manufacturer:** Playdale Playgrounds Ltd

**Finding:** There is some notable evidence of chain wear

**Action:** Monitor for any further deterioration and replace when 40% worn

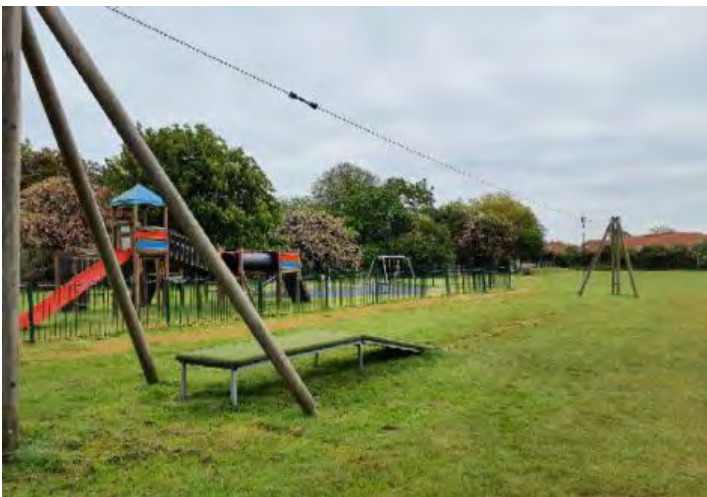
**Item:** Other - Cable Runway  
**Manufacturer:** Playdale Playgrounds Ltd

**Finding:** The cableway seat has been damaged

**Action:** Monitor for any further deterioration and replace as required

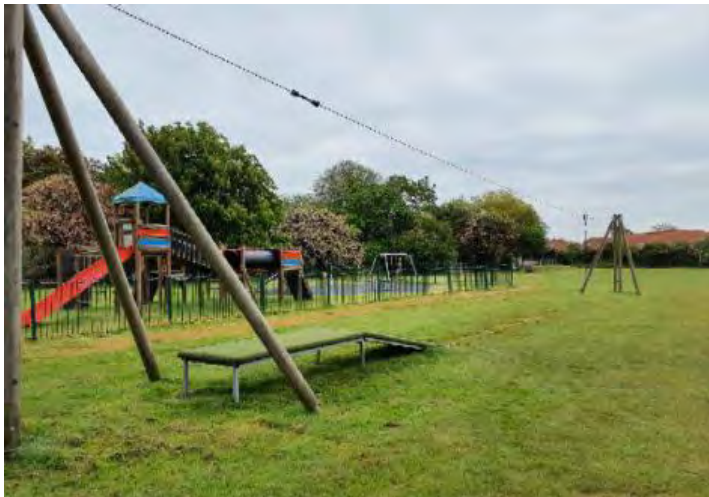
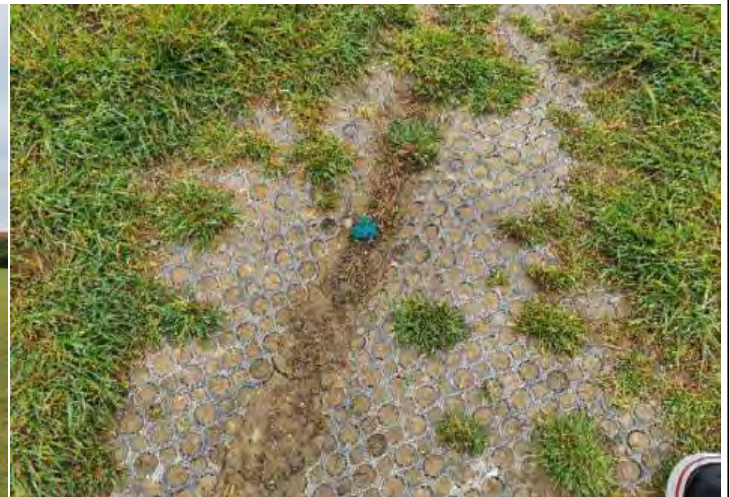
**Item:** Other - Cable Runway  
**Manufacturer:** Playdale Playgrounds Ltd

**Finding:** There are gaps opening between the grass mat tiles  
**Action:** Provide additional ties or secure / reinstate surface

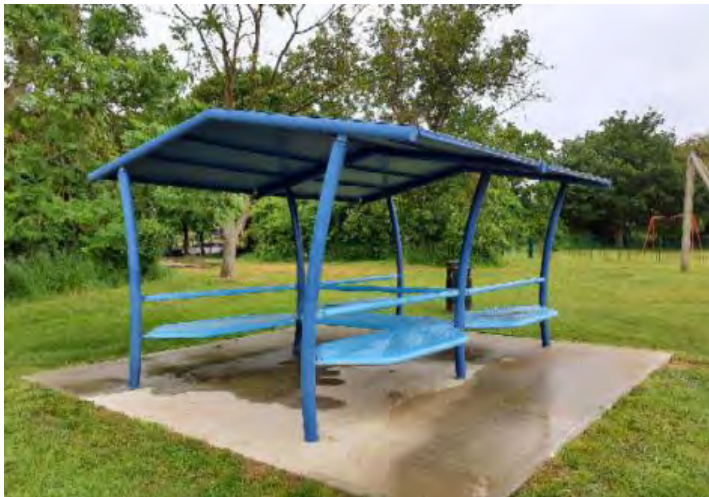
**Item:** Ancillary Items - Shelter  
**Manufacturer:** Not Identified

**Finding:** There are trip hazards at the edges of the surface

**Action:** Reinstate surrounding surface levels to remove the trip points

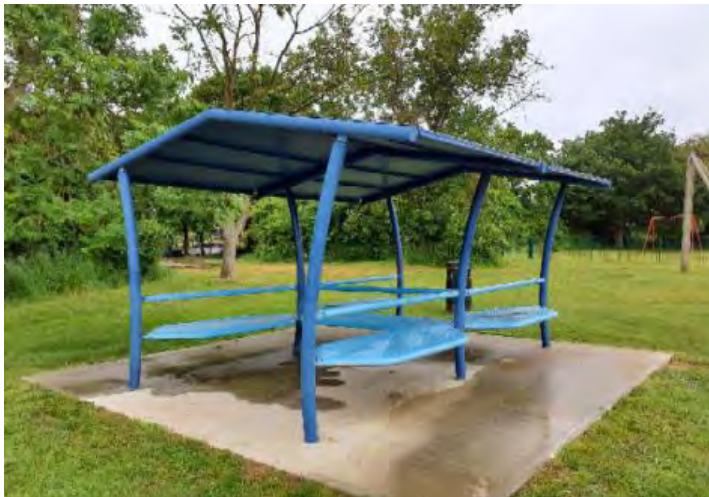
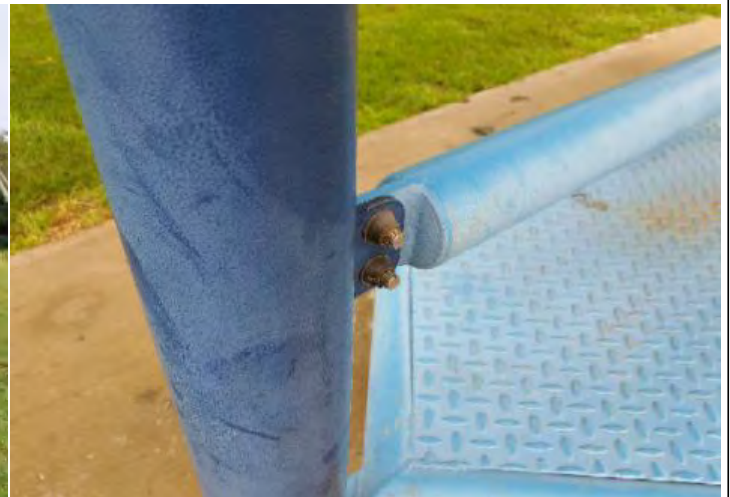
**8 - Low Risk (Finding 2)**

**Item:** Ancillary Items - Shelter  
**Manufacturer:** Not Identified  
**Risk Level:** L - Low Risk  
**Surface:** Concrete

**Finding:** There are projecting bolt thread(s) present  
**Action:** Remove excess thread length and deburr or provide cap

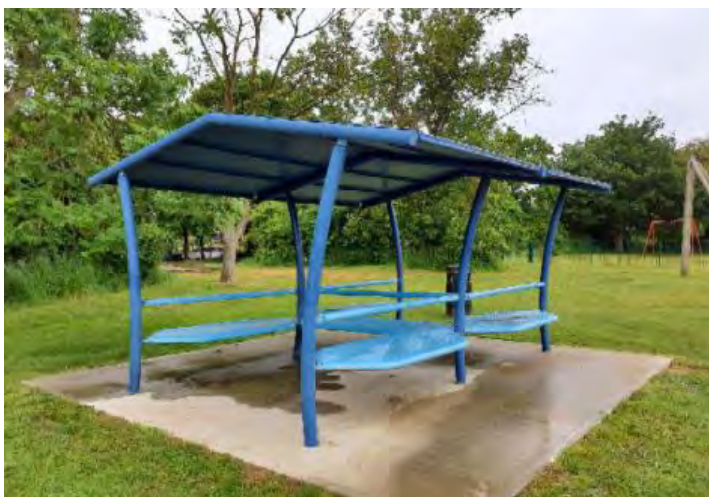
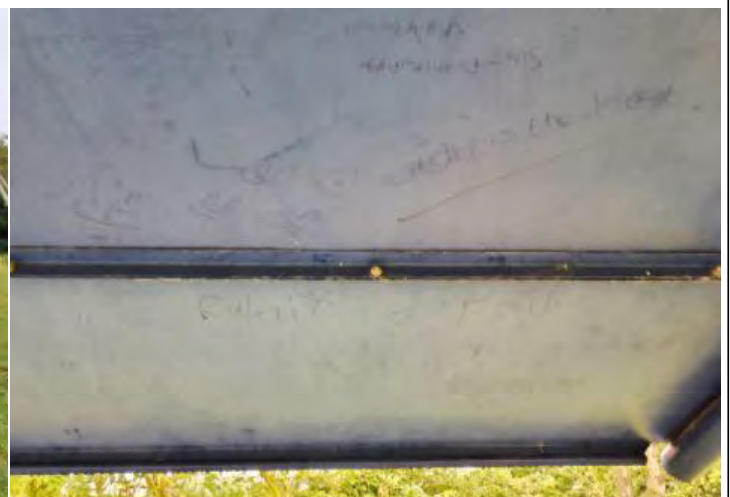
**0 - Risk Assessment not Undertaken (Finding 3)**

**Item:** Ancillary Items - Shelter  
**Manufacturer:** Not Identified  
**Risk Level:** N - Risk Assessment not Undertaken  
**Surface:** Concrete

**Finding:** There is some graffiti present  
**Action:** Remove the graffiti

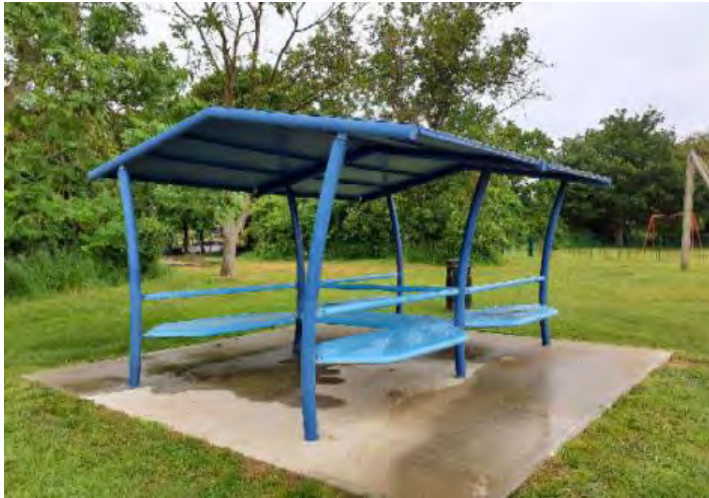
**i** 8 - Low Risk (Finding 4)

**Item:** Ancillary Items - Shelter  
**Manufacturer:** Not Identified

**Finding:** There is or are fixings missing on the item

**Action:** Replace all missing fixings

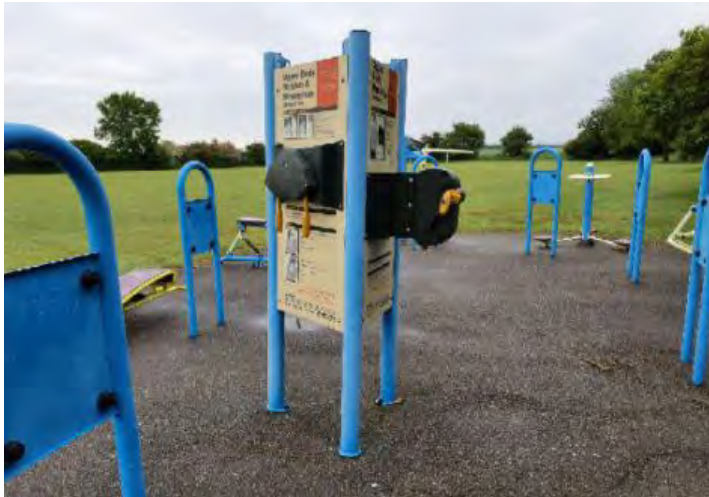
**Item:** Outdoor Fitness Equipment - Fit Point  
**Manufacturer:** Playworld Systems (Europe) Ltd

**Finding:** There is or are fixings missing on the item

**Action:** Replace all missing fixings

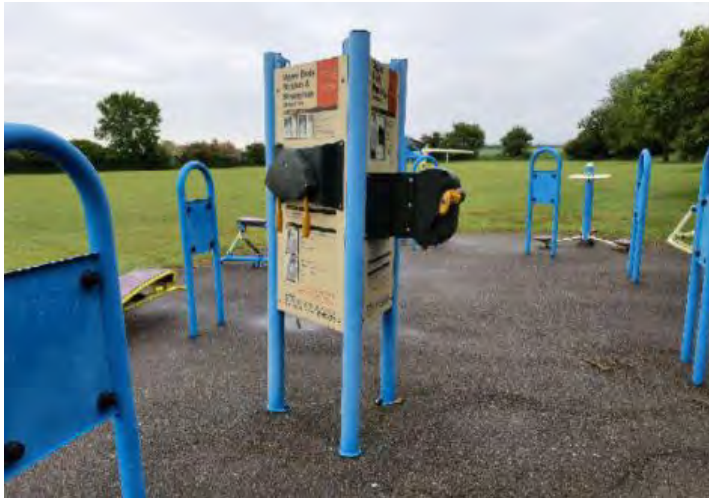
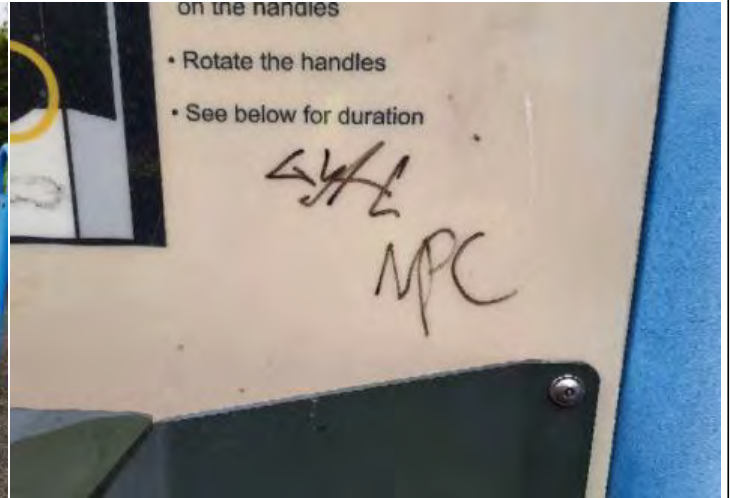
**Item:** Outdoor Fitness Equipment - Fit Point  
**Manufacturer:** Playworld Systems (Europe) Ltd

**Finding:** There is some graffiti present

**Action:** Remove the graffiti

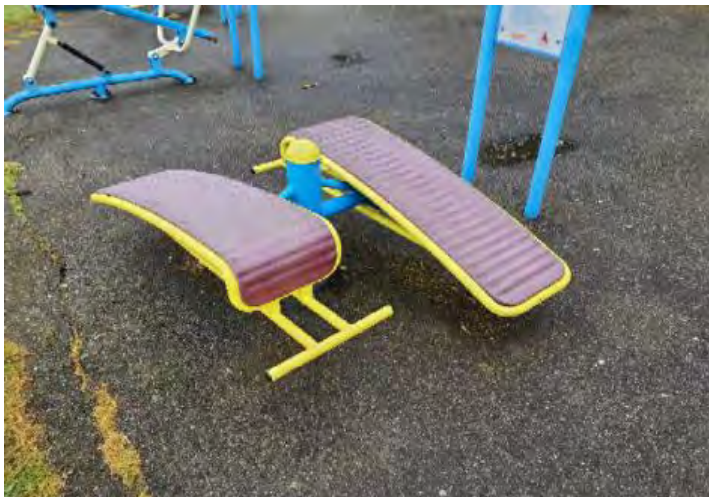
**Item:** Outdoor Fitness Equipment - Ab Station  
**Manufacturer:** Playworld Systems (Europe) Ltd

**Finding:** The paintwork on this item has been damaged or worn exposing the metal underneath which is rusting

**Action:** Treat any rusting components and repaint

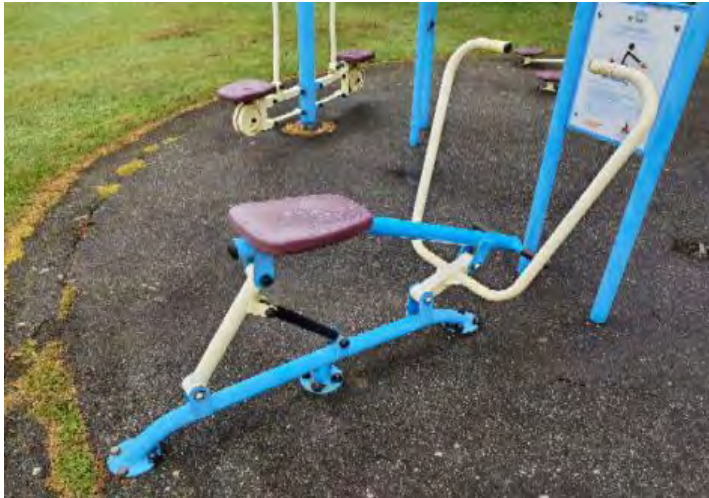
**Item:** Outdoor Fitness Equipment - Rower  
**Manufacturer:** Playworld Systems (Europe) Ltd

**Finding:** There is/are bolt cap covers missing or damaged on the item

**Action:** Replace missing or damaged bolt cap covers

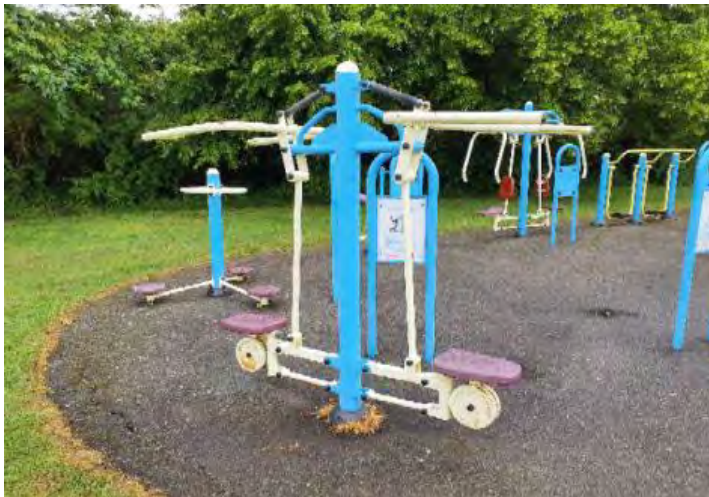
**Item:** Outdoor Fitness Equipment - Lateral Pull Down  
**Manufacturer:** Playworld Systems (Europe) Ltd

**Finding:** The fixings have corroded excessively

**Action:** Replace all corroded fixings

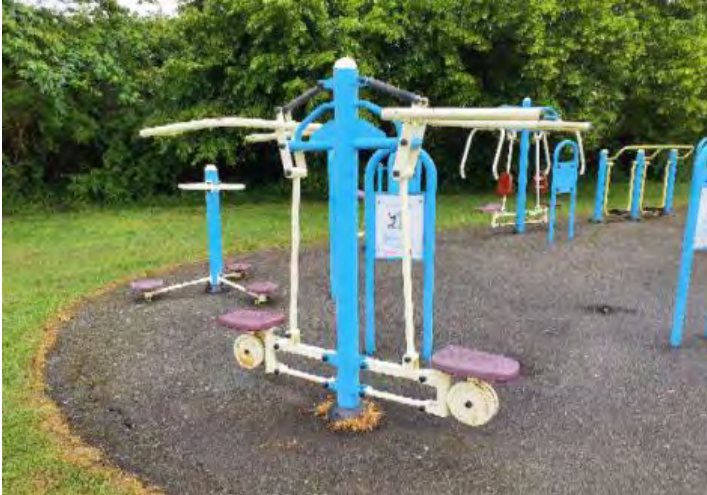
**Item:** Outdoor Fitness Equipment - Lateral Pull Down  
**Manufacturer:** Playworld Systems (Europe) Ltd

**Finding:** There is/are bolt cap covers missing or damaged on the item

**Action:** Replace missing or damaged bolt cap covers

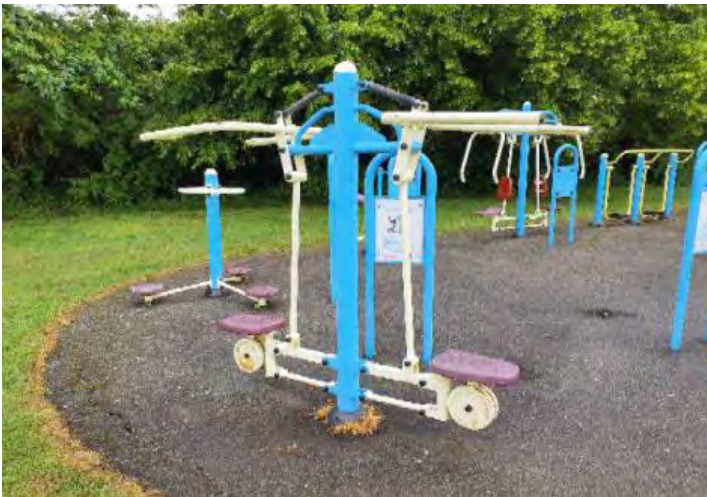
**Item:** Outdoor Fitness Equipment - Lateral Pull Down  
**Manufacturer:** Playworld Systems (Europe) Ltd

**Finding:** The paintwork on this item has been damaged or worn exposing the metal underneath which is rusting

**Action:** Treat any rusting components and repaint

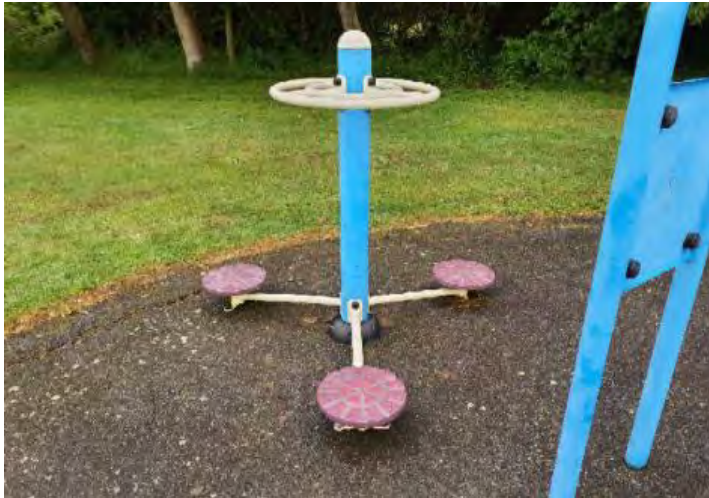
**6 - Low Risk (Finding 1)**

**Item:** Outdoor Fitness Equipment - Hip Twister  
**Manufacturer:** Playworld Systems (Europe) Ltd  
**Risk Level:** L - Low Risk  
**Surface:** Bitmac

**Finding:** The rotating user station is not appropriately marked with a guideline of user direction and/or the original position as required by BS EN 16630

**Action:** Monitor - No remedial work recommended
