# TOLLESHUNT D'ARCY PARISH COUNCIL

## AGENDA

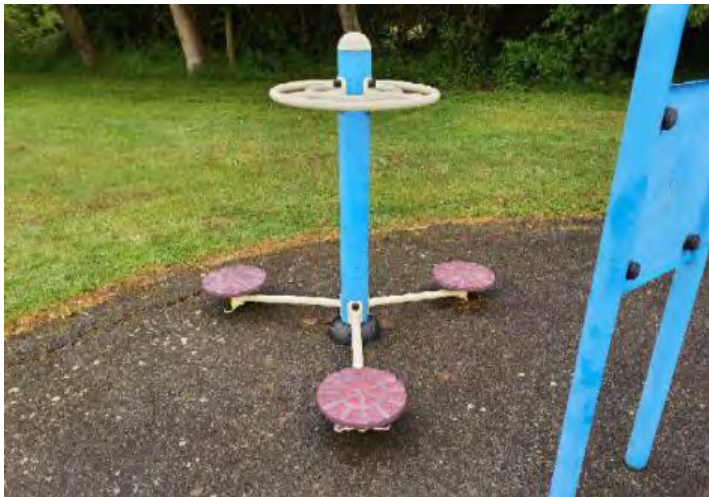
**8 - Low Risk (Finding 2)**

**Item:** Outdoor Fitness Equipment - Hip Twister  
**Manufacturer:** Playworld Systems (Europe) Ltd  
**Risk Level:** L - Low Risk  
**Surface:** Bitmac

**Finding:** The deflection of the rotating user station exceeds the maximum 105 degrees required by BS EN 16630

**Action:** Monitor - No remedial work recommended

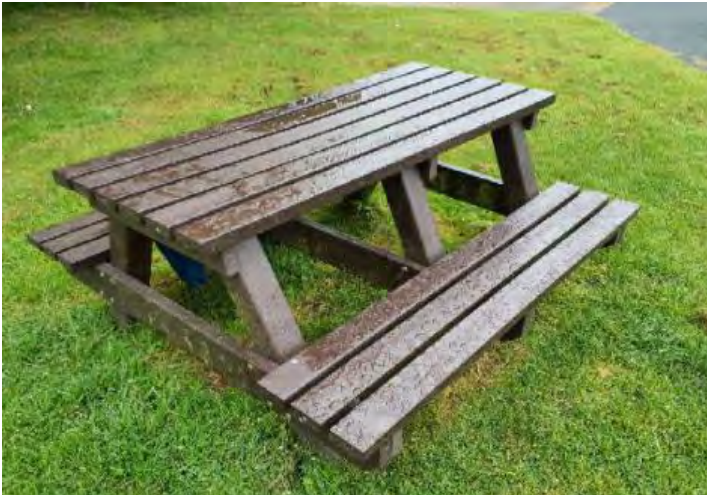
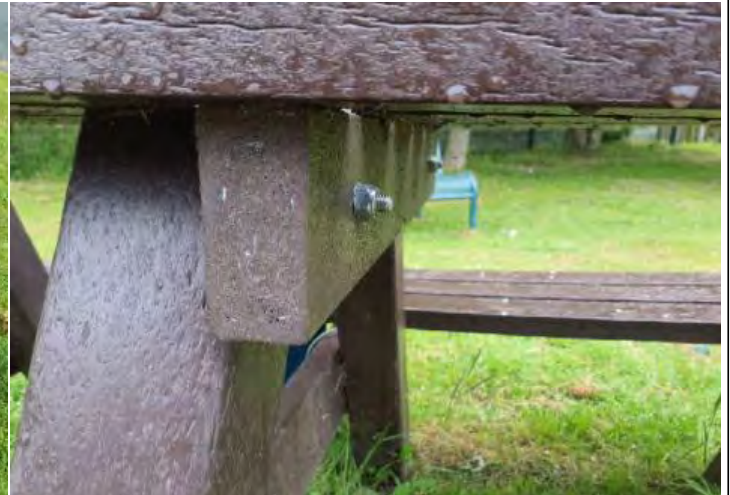
**Finding:** There are projecting bolt thread(s) present

**Action:** Remove excess thread length and deburr or provide cap

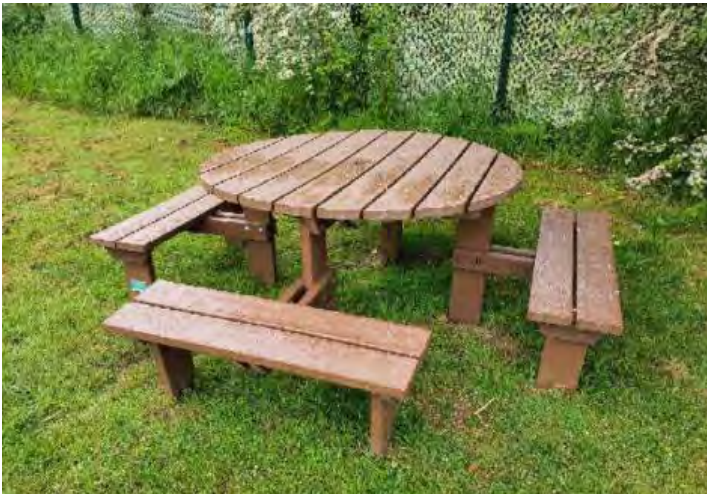
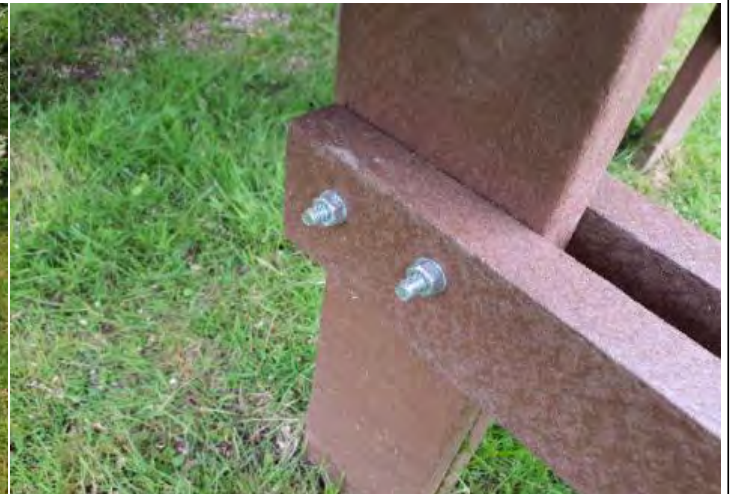
**Finding:** There are projecting bolt thread(s) present

**Action:** Remove excess thread length and deburr or provide cap

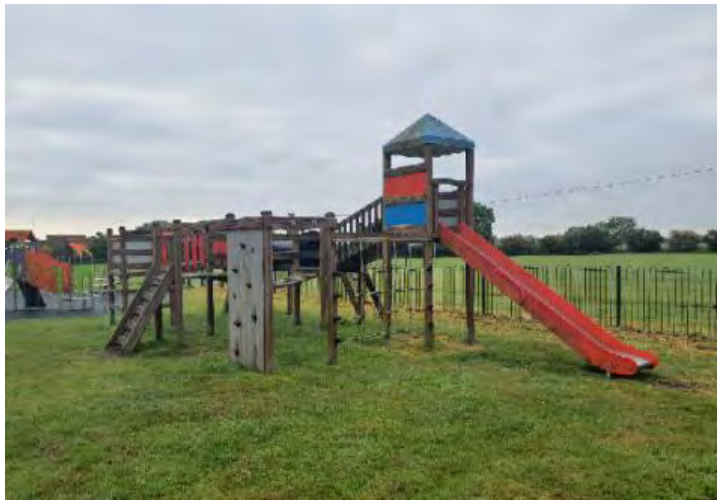
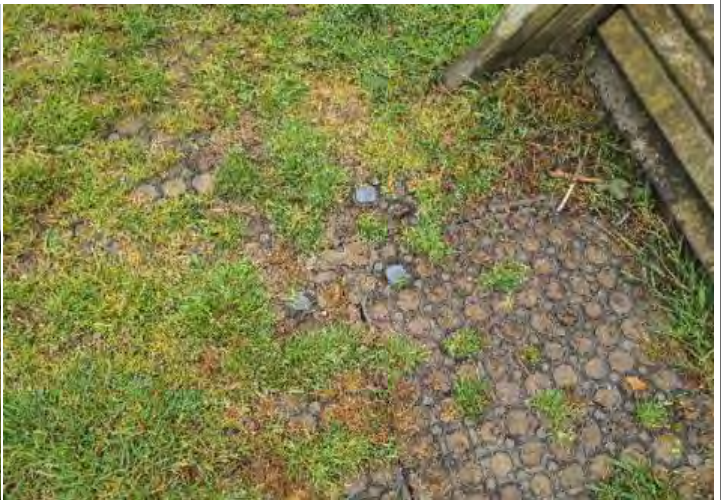
**i** 5 - Very Low Risk (Finding 1)

**Finding:** Fixing Pins have been installed in the impact areas of the grass mats **Action:** Remove pins from impact areas

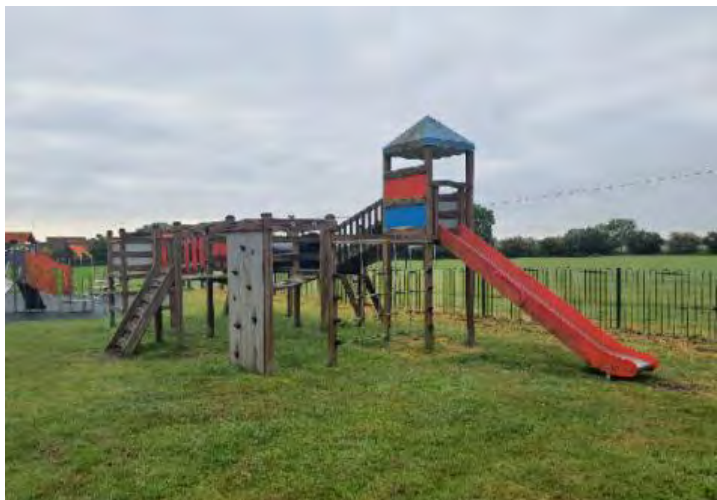
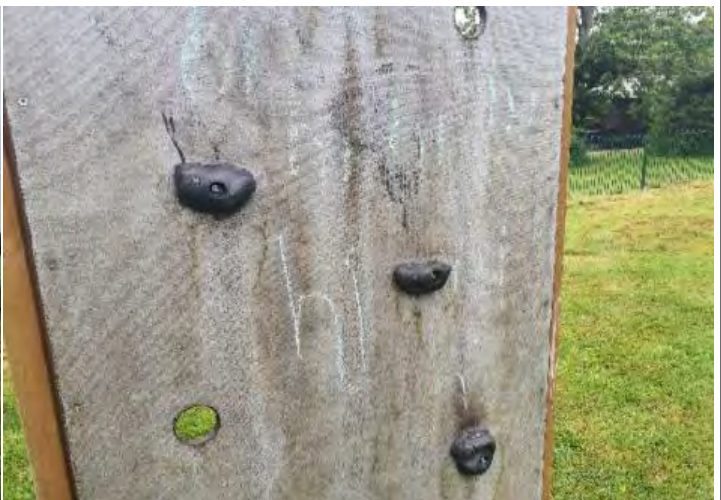
**i** 0 - Risk Assessment not Undertaken (Finding 2)

**Finding:** There is some graffiti present **Action:** Remove the graffiti

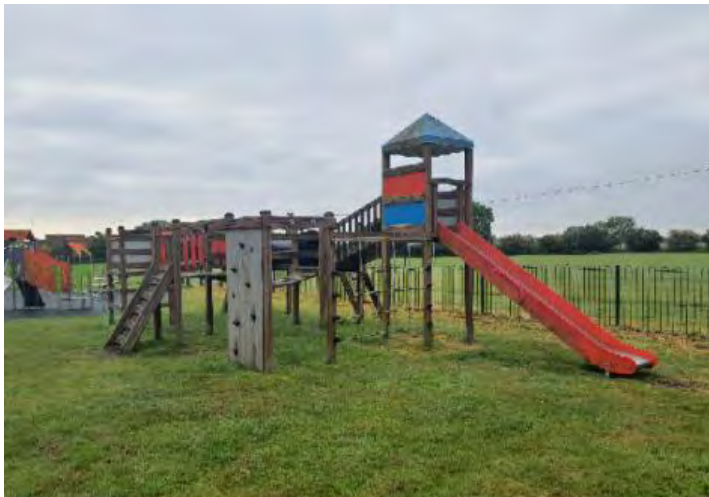
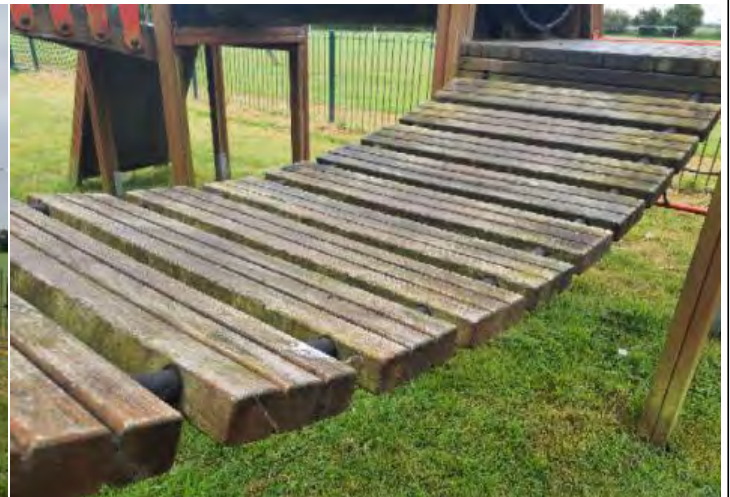
**Finding:** There is algae or moss on the surface of the equipment

**Action:** Clean and treat appropriately

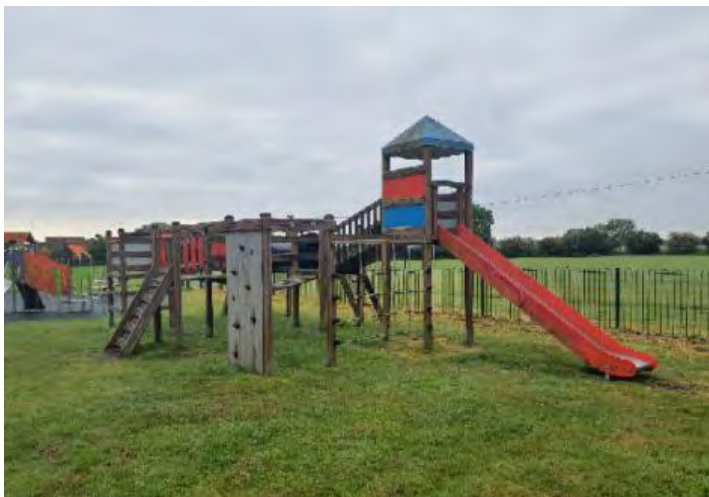
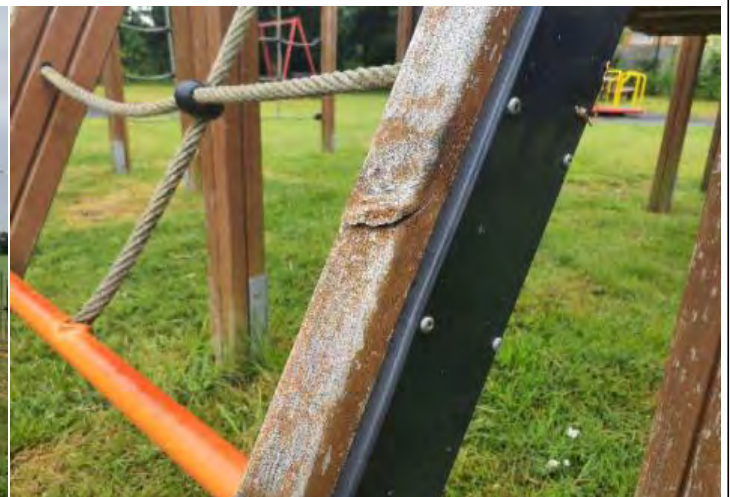
**Finding:** Parts of the timber are rough or splintered

**Action:** Remove all rough or sharp edges

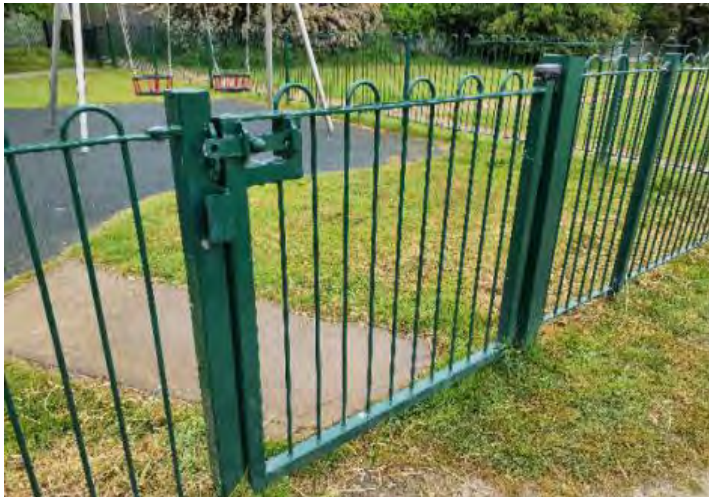
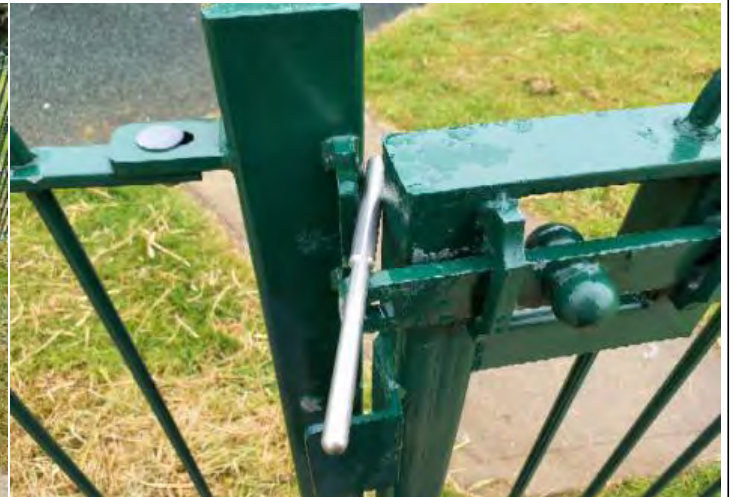
**8 - Low Risk (Finding 1)**

<b>Finding:</b> There are openings that are less than 12mm that could trap or crush fingers	<b>Action:</b> Provide a 12mm gap throughout full range of motion at both sides of gate
---	---

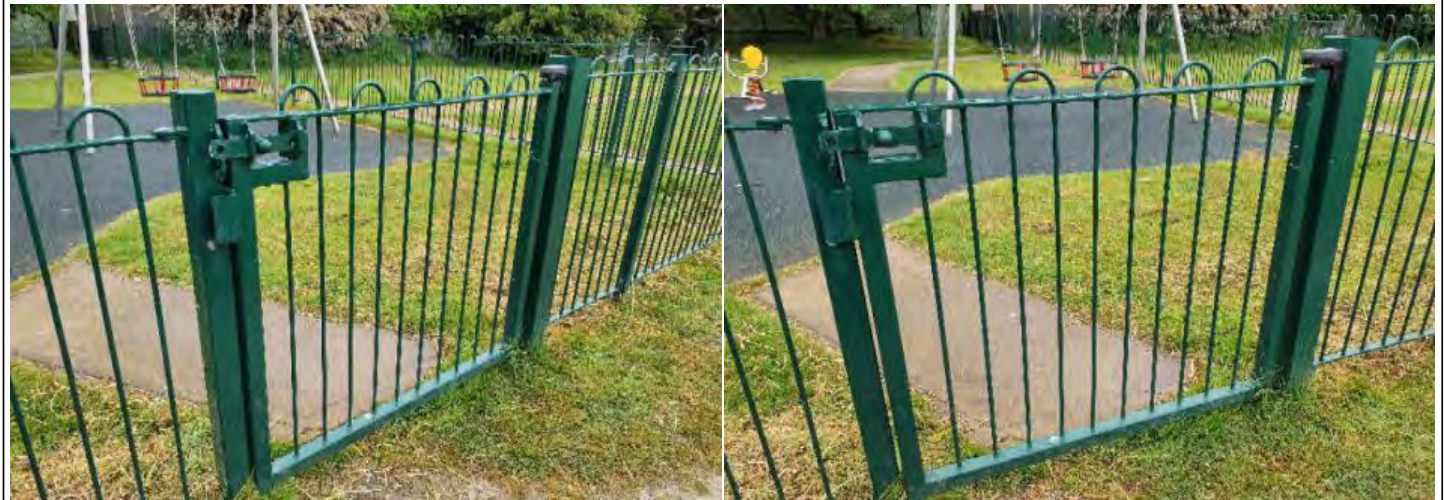
**8 - Low Risk (Finding 2)**

<b>Finding:</b> The gate is closing too quickly (less than 4 seconds)	<b>Action:</b> Take corrective action to ensure that the gate closes in 4-8 seconds
---	---
